CULTURAL HEALTH ASSESSMENTS & WATER MANAGEMENT FOR THE RAKAHURI – WAIMAKARIRI ZONE

Prepared by Representatives of Te Ngai Tuahuriri and Tipa
& Associates

October 2016

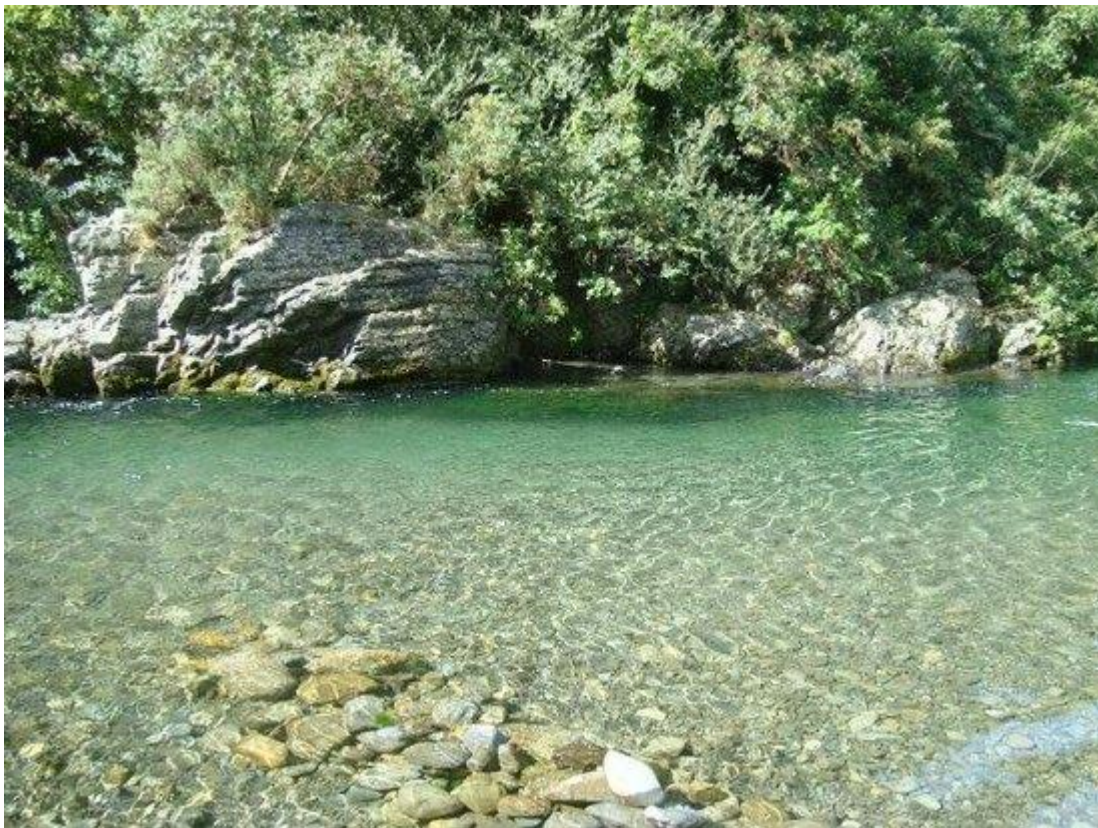
WATER QUALITY	RECREATION
<ul style="list-style-type: none"> The site exceeds the fine sediment cover set in the LWRP. The annual maximum temperature failed to meet target in the LWRP at least once Total suspended sediment is not an issue at this site. 	<ul style="list-style-type: none"> E-coli is below the standard <ul style="list-style-type: none"> The quality of water is suitable for contact recreation. The trigger level of 550 (which requires action) was triggered once between 2011 – 2015)

A photo of a swimming hole at Ashley Gorge

- Restore water quality.
- Investigate the quality of the water to ensure that it is safe for gathering. Whanau do use this site and their safety has to be paramount.
- Determine the flows that needed to maintain a visible connected flow ki uta ki tai.
- Riparian planting is to be prioritised. A catchment management plan to reduce the expanse of willows is to be developed.

- Minimise impacts from landuses in the headwaters by establishing a larger buffer zone that is planted appropriately and fenced off.
- Continue to implement with Te Ngai Tuahuriri Runanga the agreed drain cleaning protocol
- Continue to work with Manawhenua on initiatives that involve storage or “new water” within the zone.
- Shingle management needs to be reviewed. It is unclear how dry reaches, low flows and flood control measures cumulatively impact fish habitat and fish populations.
- The impact of dewatered reaches on the composition of fish populations in this reach needs to be investigated.

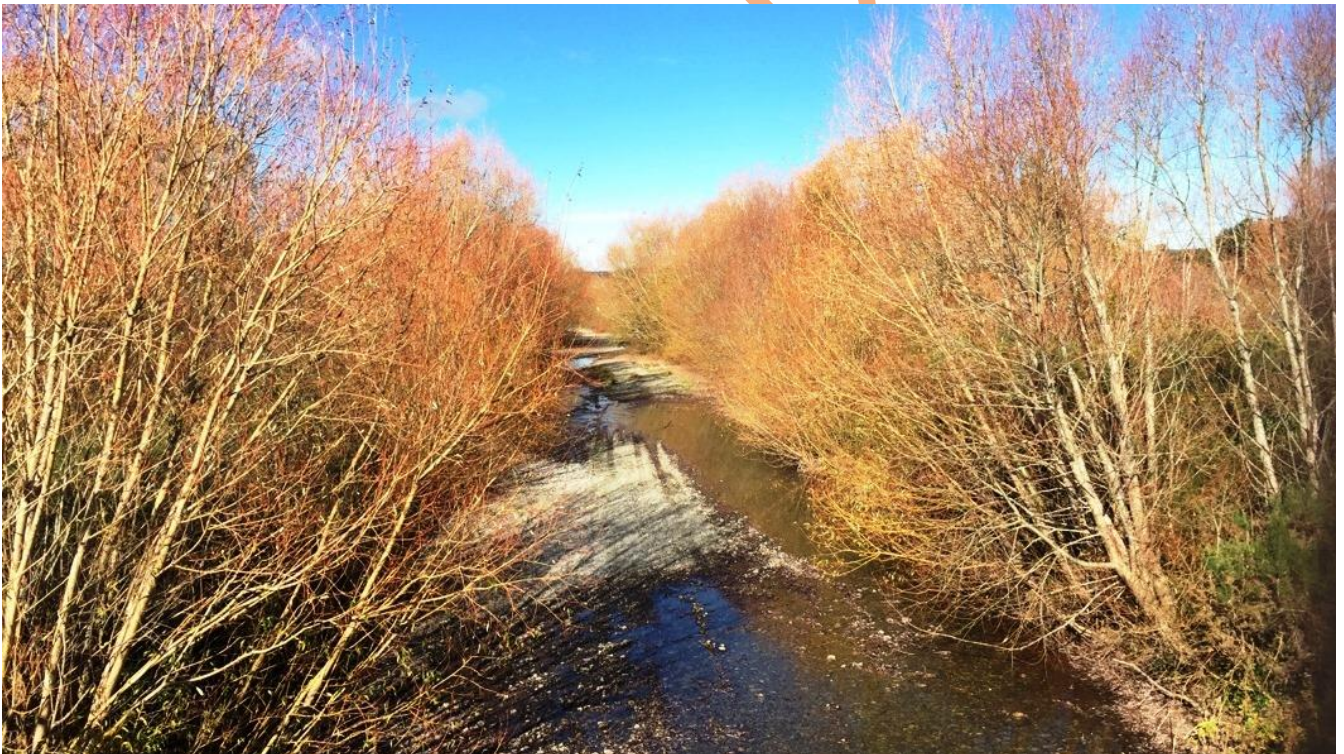
WATER QUALITY	MCI	NUTRIENTS
<ul style="list-style-type: none"> The dissolved oxygen failed to meet target in the LWRP at least once 	<p>In 2015, the QMCI met the LWRP target</p>	<ul style="list-style-type: none"> DIN levels exceed thresholds in LWRP <p>Going forward -</p> <ul style="list-style-type: none"> Levels in the LWRP are not to be lessened (weakened) provided they are sufficient to protect koura. There is to be 100% compliance with the thresholds in the LWRP.

Looking downstream from the bridge on Birch Hill Road

- Protect water quality. Prioritise retention of the “A” band classifications.
- Investigate the ways in which connections to and use of the reserve can be enabled.
- Maintain good flows in the stream. Investigate the contribution that this river makes to the variability in the mainstem Rakahuri
- Riparian planting is needed to replace the willows.
- Minimise impacts from adjacent landuse by establishing a larger buffer zone that is planted and fenced off. Stock are to be excluded.
- Monitor water quality, which will include ongoing cultural monitoring.

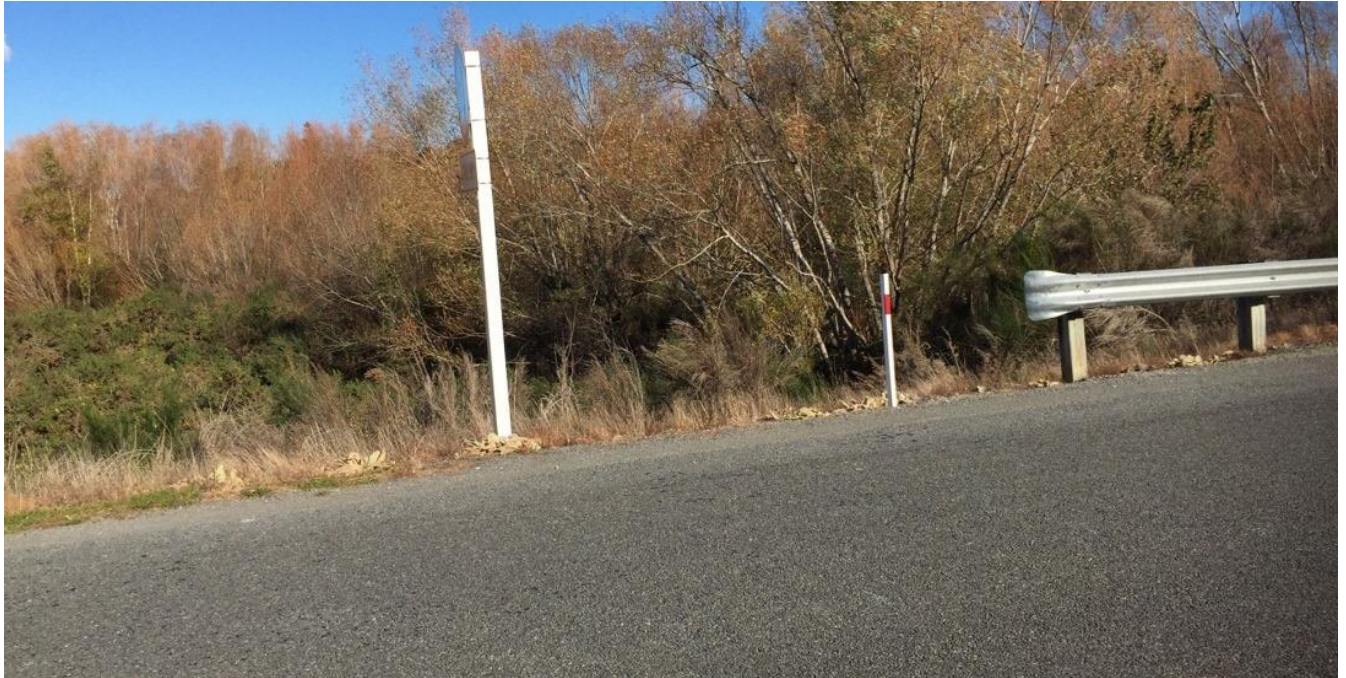
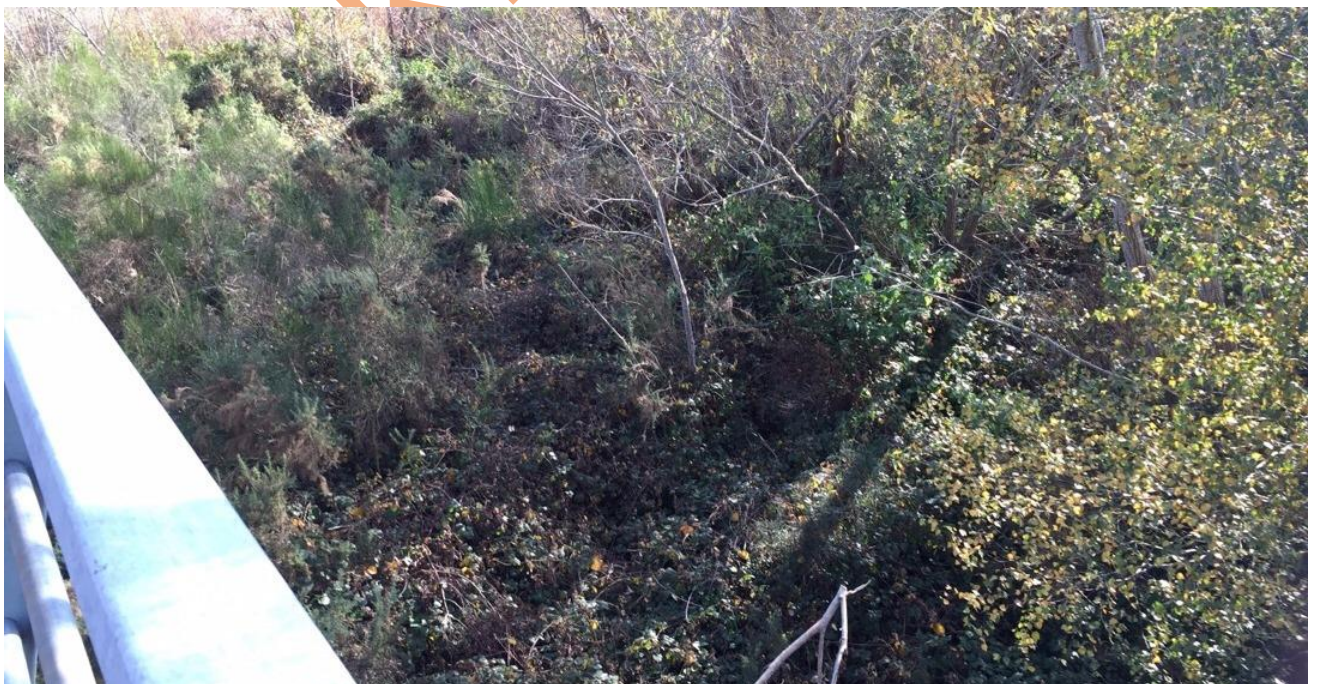
WATER QUALITY	MCI	NUTRIENTS
The dissolved oxygen failed to meet target in the LWRP at least once	There is only one QMCI assessment. In 2015 it met the LWRP target.	<ul style="list-style-type: none"> DIN levels exceed thresholds in LWRP

Looking towards the river (below) looking down into the channel (bottom photo)

- Protect water quality. Prioritise retention of the “A” band classifications.
- Investigate the ways in which connections to and use of the reserve can be enabled.
- Increase the flows in the stream. Investigate the contribution that this river, like the Garry, makes to the variability in the mainstem Rakahuri
- Riparian planting is needed to replace the willows.
- Minimise impacts from adjacent landuse by establishing a larger buffer zone that is planted and fenced off. Stock are to be excluded.
- Monitor water quality, which will include ongoing cultural monitoring.

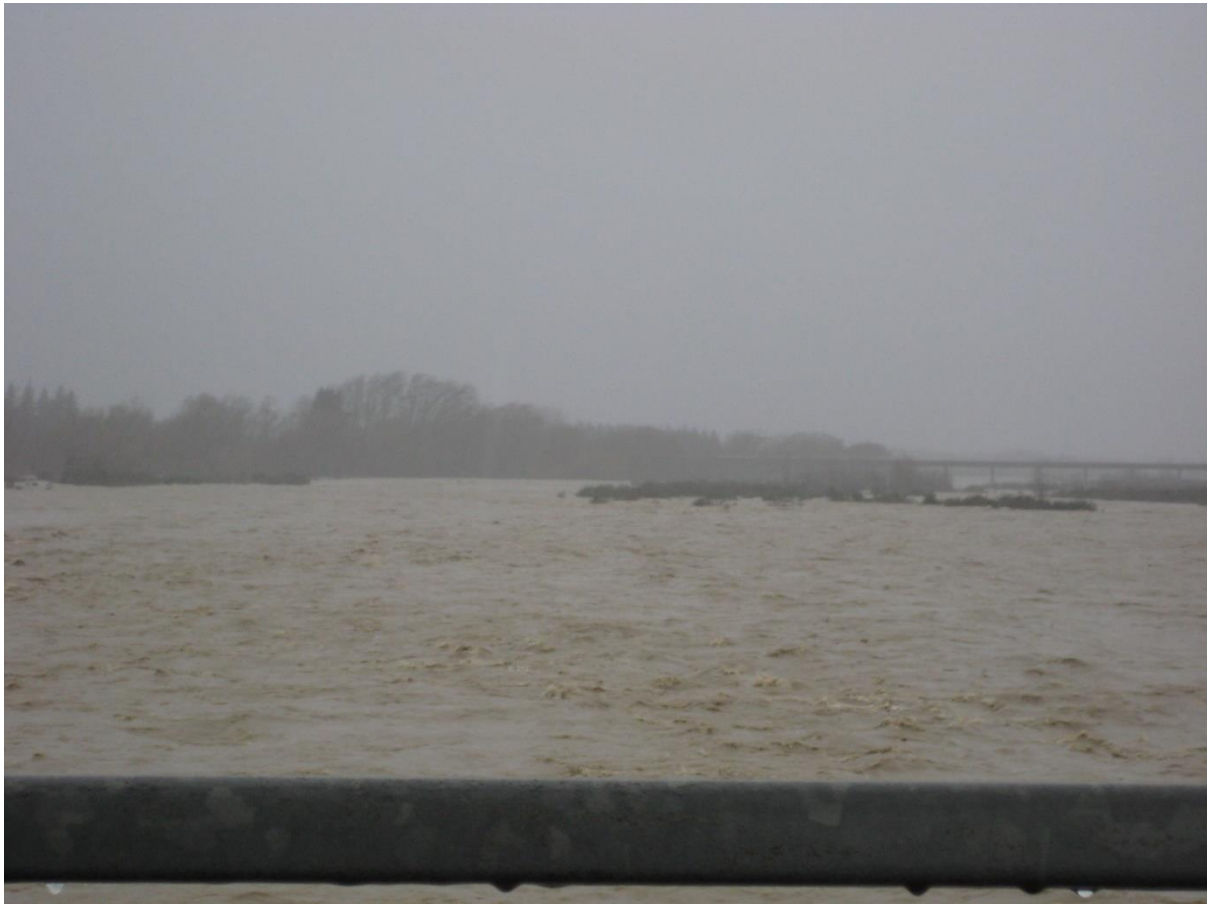
The Rakahuri (at Rangiora) in flood

- Improve weed management
- Plant native plants to attract birds – include the planting of flaxes for weavers to use
- Maintain flow that affords swimming for a range of different ages, including adults
- Agree summer flows that restore a braided character.
- Identify the flows needed to maintain a visible connected flow ki uta ki tai

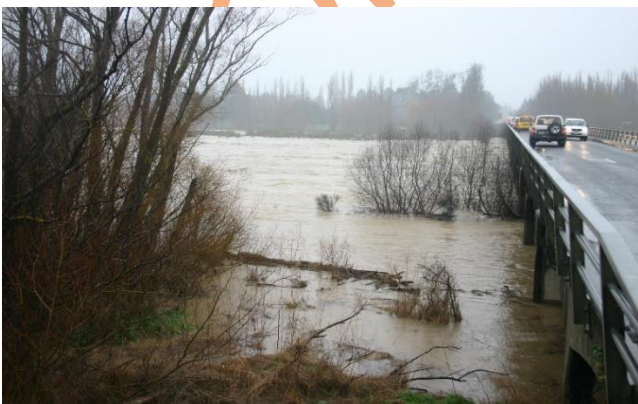
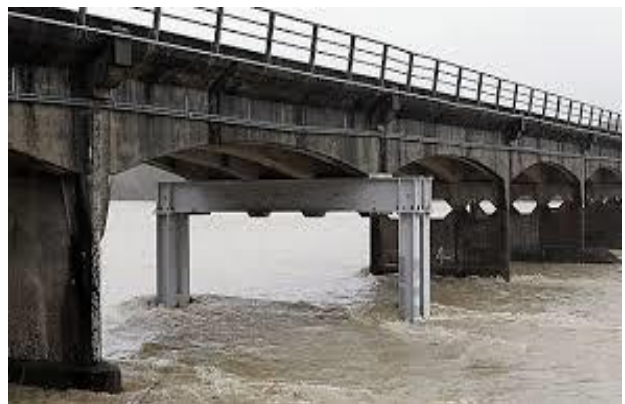
The Ashley in flood. Whanau want to see flow variability set in the flow regime. Flood management practices need to consider instream needs.

- Recreate habitats (e.g. wetlands have been filled in. Runange would like to work with Ecan to identify opportunities to recreate)
- Shingle management needs to be reviewed. It is unclear how dry reaches, low flows and flood control measures cumulatively impact fish habitat and fish populations.
- Improved weed management.
- Review of the willow management programme
- Plant natives on the riparian margins – include flaxes for weavers to use
- Agree to a water quality standard that means water is safe for swimming
- Increase summer flows that improve water quality and support whanau use.

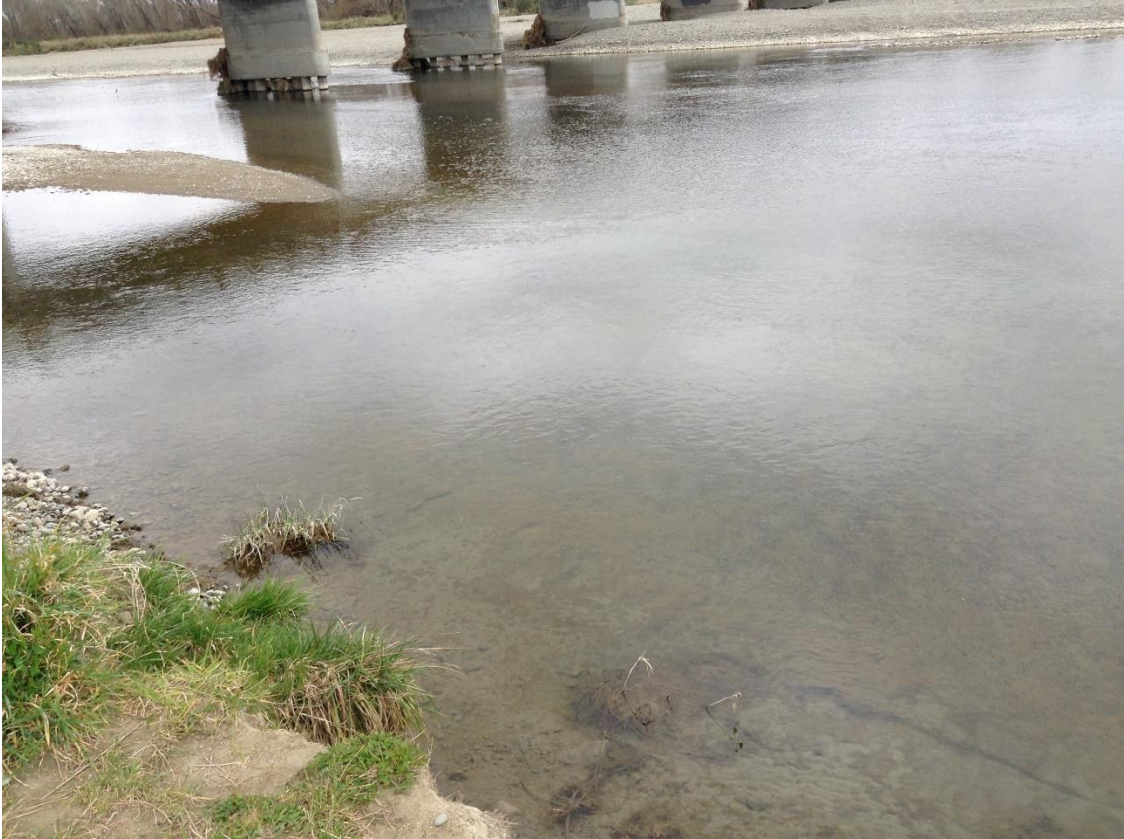
Sediment concerns in the lower Rakahuri

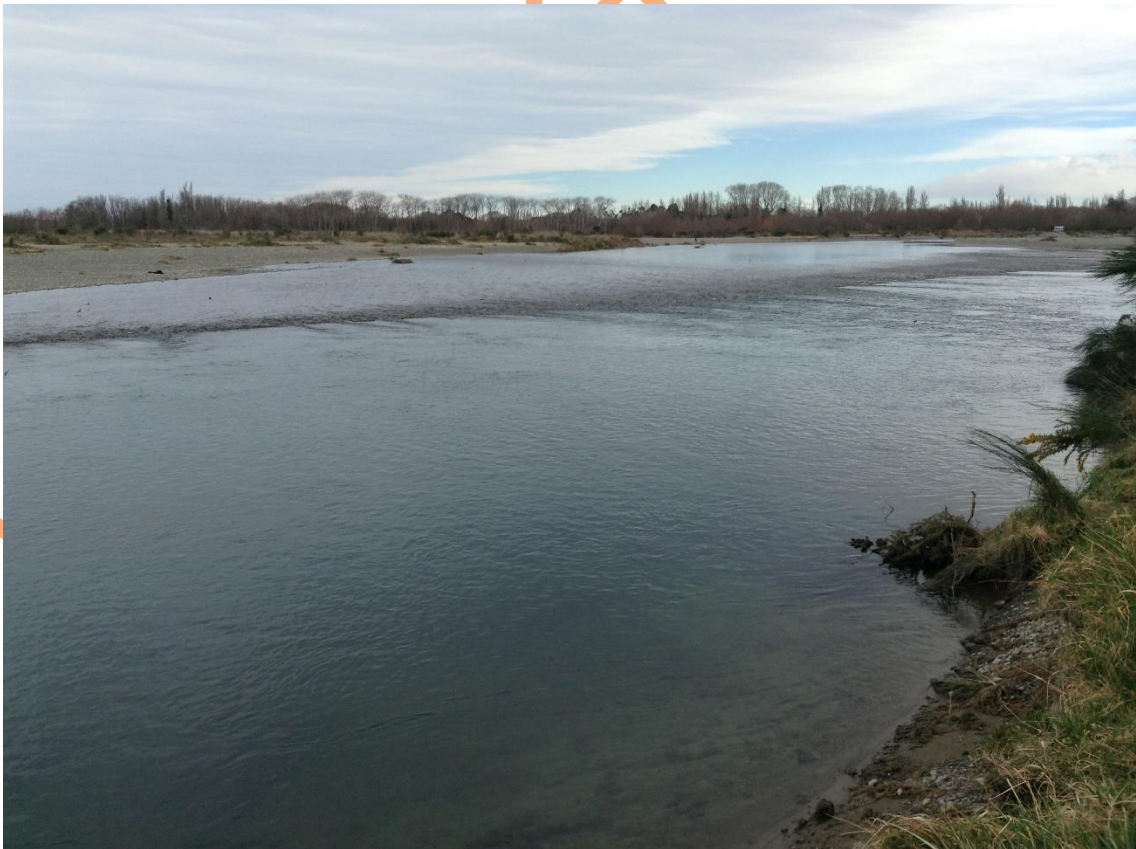
Where the park is now was all wetlands will the Catchment Board filled them in

This site has obstructed the use of our beneficial right to the Fenton Reserve and the connection to Te Aka Aka which is an inherited right ... by building stopbanks and diverting the river away from this fishing reserve.

Looking across the river at the Raupo Berm

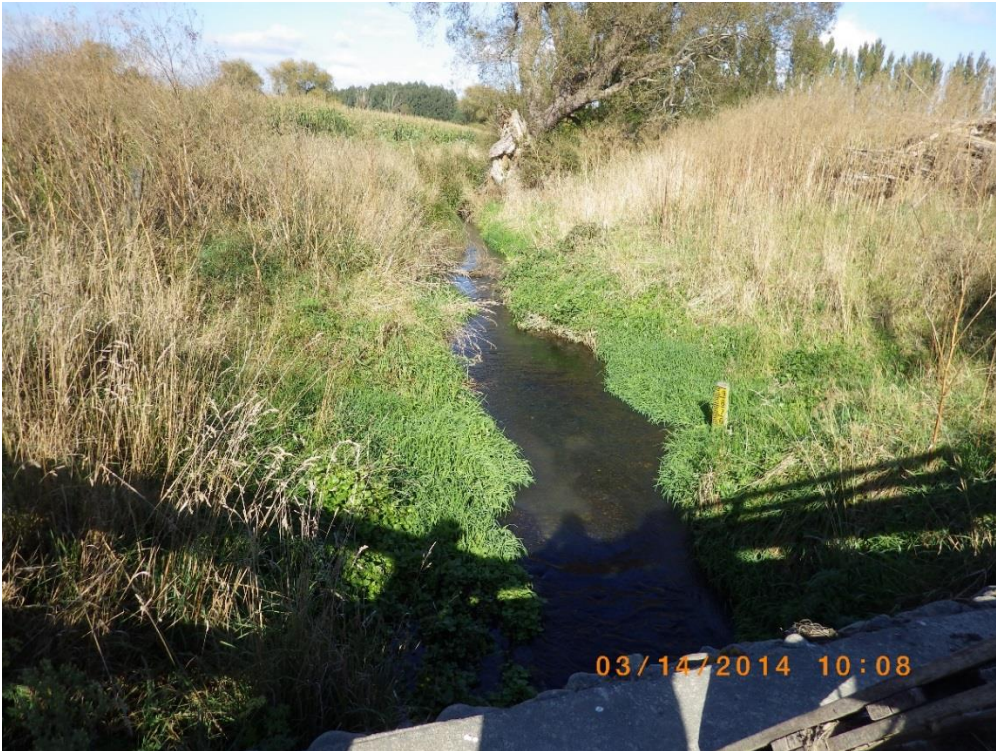
Taranaki Stream
(Kaiapoi Pa) Looking
upstream

- Channel is open with grasses at the stream edge.
- Water was clear.

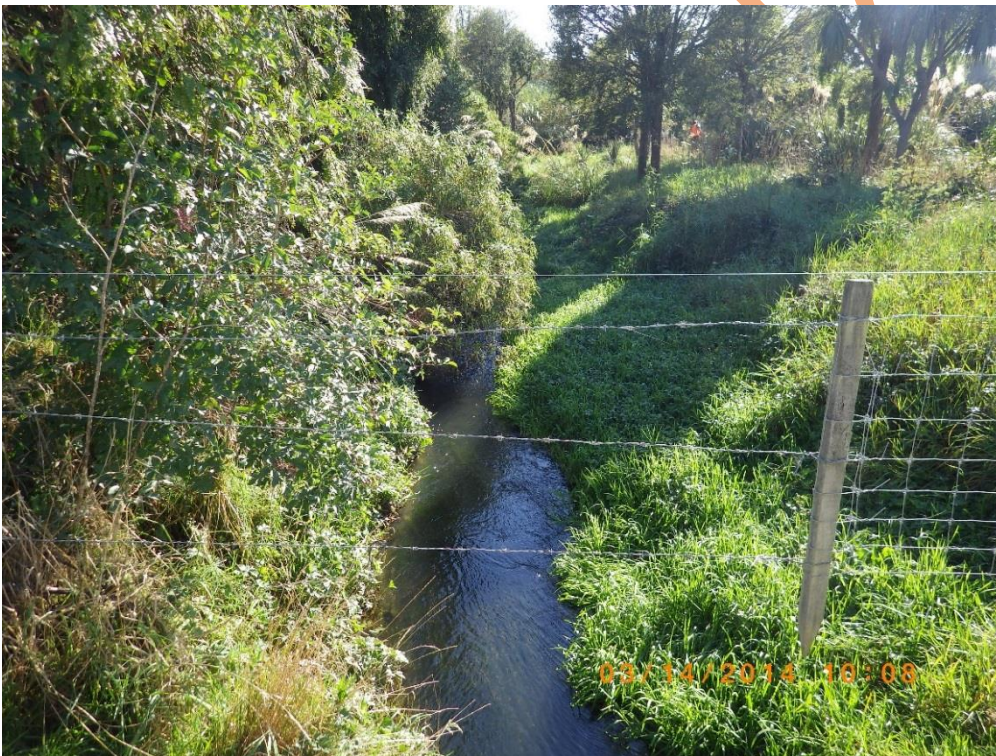
Taranaki Stream
(Kaiapoi Pa) Looking
downstream from
Preece Road.

- Riparian planting established on one side.
- Water was clear.
- Kaiapoi Pa is to the right – historically it would have been to the left.

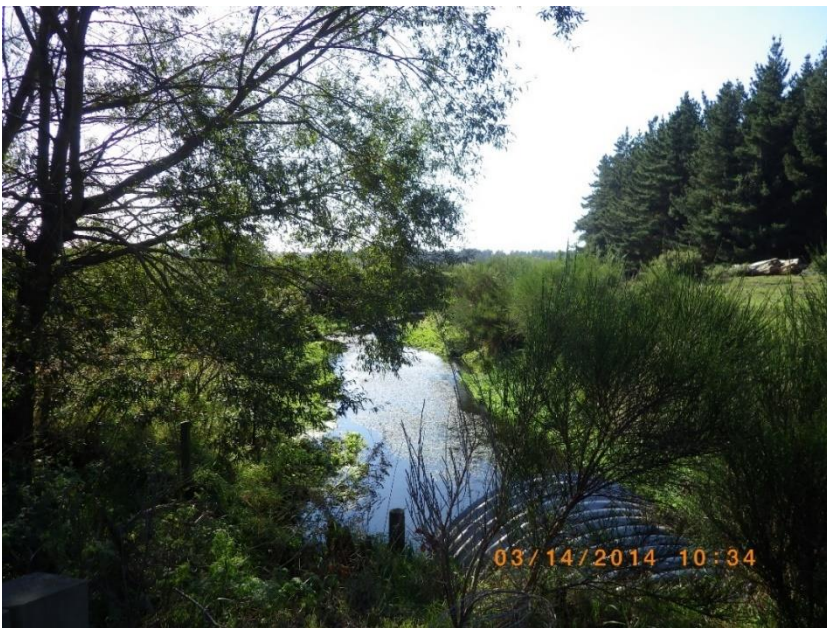
Taranaki Stream - Looking downstream

- Channel is open with grasses at the stream edge.
- Water was clear but choked with weeds
- Was introduced plants with very few natives
- The fencing is close to the waters edge.

- Enhance water quality. Nutrient enriched water is not supported.
- Reconstruct connections to other waterways using the historic patterns as a starting point. For example Taranaki Stream is to flow on the east side of the reserve.
- Connect this site with downstream reaches via the Taranaki floodgate retrofit.
- Plant vegetation on at least one side to provide shelter and cover for the river channel.
- Establish a reasonable sized buffer between Taranaki Stream and the adjacent lands.
- Monitor water quality, which will include ongoing cultural monitoring. This is to ensure that water is not nutrient enriched.
- Continue to implement with Te Ngai Tuahuriri Runanga the agreed drain cleaning protocol.
- Consents in this catchment should not be processed non-notified.

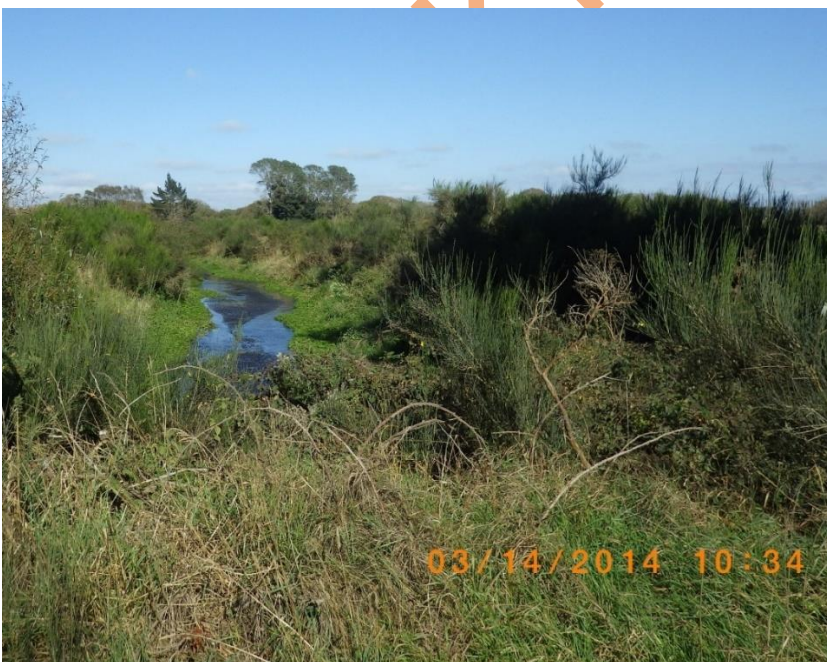
Taranaki Stream - Looking upstream

- Channel is open with grasses at the stream edge.
- Water was clear but choked with weeds
- Was introduced plants with very few natives
- It is unknown whether or not the waters are nutrient enriched.

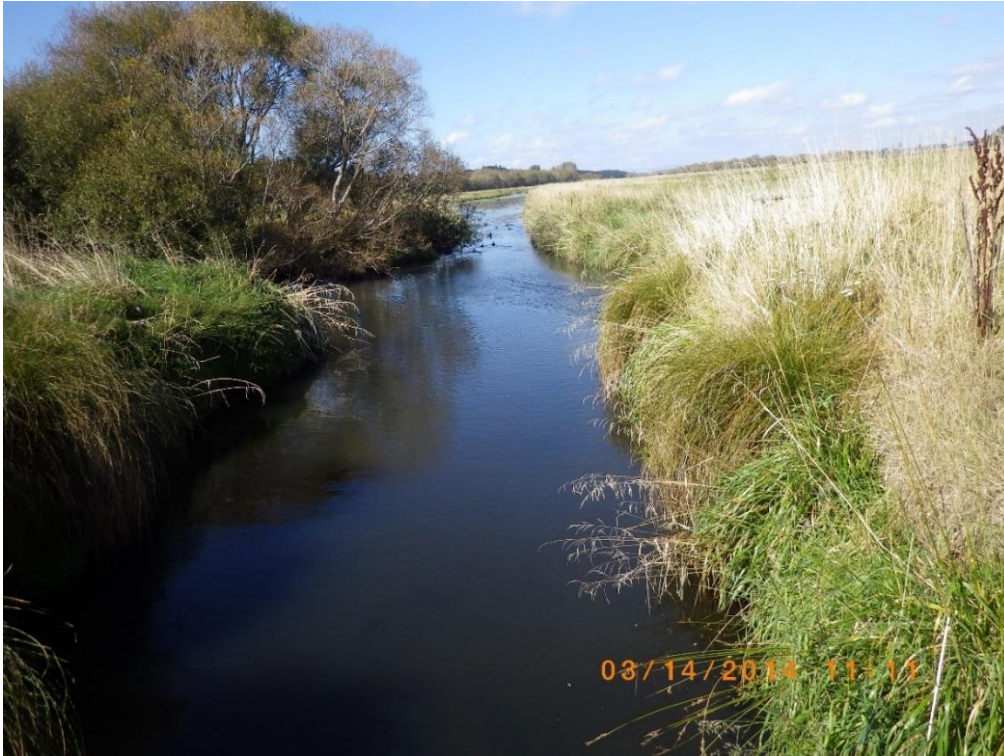
Taranaki Stream -
Looking upstream

- There are grasses at the stream edge.
- Willow gives limited shelter

It is unknown whether or not the waters are nutrient enriched.

- Enhance water quality. Te Ngai Tuahuriri notice a decline as you move down the stream. Deterioration is not supported.
- Reconstruct connections to other waterways using the historic patterns as a starting point. For example Taranaki Stream is to flow on the east side of the reserve.
- Connect this site with downstream reaches via the Taranaki floodgate retrofit.
- Plant vegetation on at least one side to provide shelter and cover for the river channel.

- Establish a reasonable sized buffer between Taranaki Stream and the adjacent lands.
- Monitor water quality, which will include ongoing cultural monitoring. This is to ensure that water is not nutrient enriched.
- Continue to implement with Te Ngai Tuahuriri Runanga the agreed drain cleaning protocol
- Consents in this catchment should not be processed non-notified.

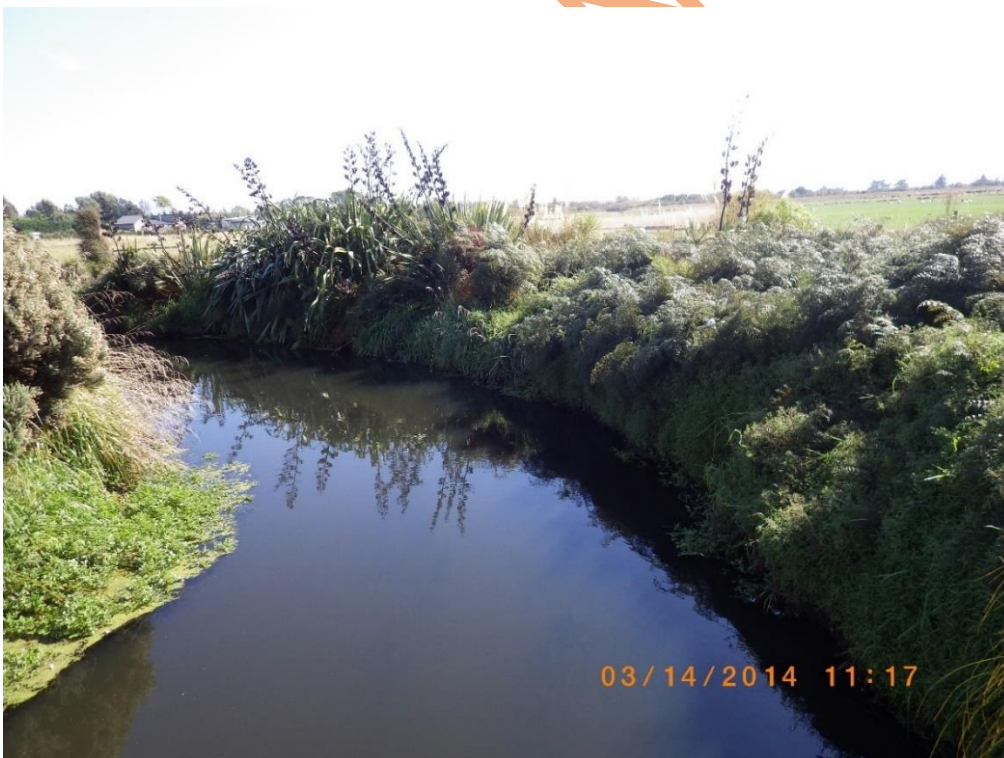
Taranaki Stream -
Looking downstream

- Channel has riparian planting on one side offering some shade.
- Water was clear but can be discoloured.

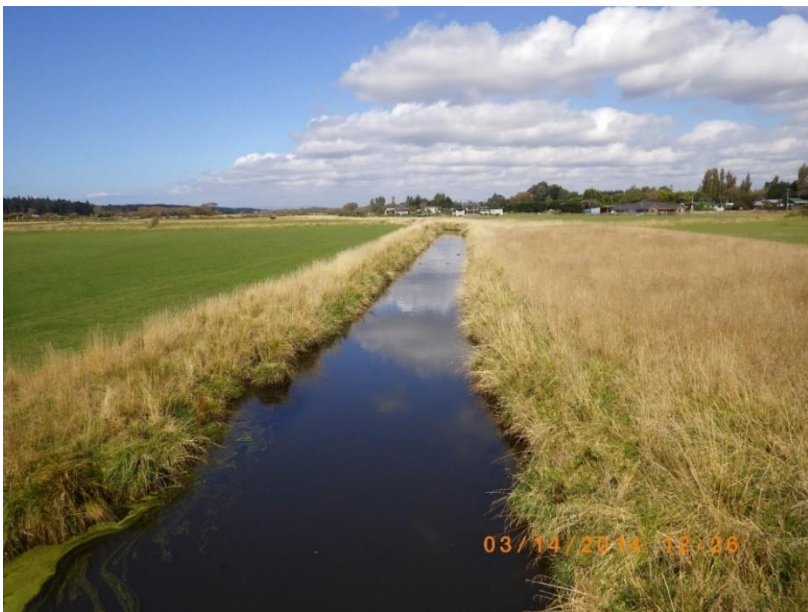
Taranaki Stream - Standing on the floodgate looking upstream

- There are grasses at the stream edge. But this photos shows the difference in the approach of farmers to the size of buffer. The larger buffer on the true left of the river is supported.
- Further planting is needed in the buffer that has been set aside,

- Enhance water quality – the quality needs to be consistent with that upstream. There is to be no deterioration downstream of the pa.
- Minimise sediment inputs and impacts from adjacent landuse through retention of a sizeable buffer that is planted with indigenous shrubs and trees.
- Retrofit and redesign the flood gate to enable passage of fish species. Whanau want it opened permanently
- Monitor activity around the gate during the whitebait season
- Monitor water quality, which will include ongoing cultural monitoring. This is to ensure that water is not nutrient enriched.
- Continue to implement with Te Ngai Tuahuriri Runanga the agreed drain cleaning protocol
- Consents in this catchment should not be processed non-notified.

“Leave it [the floodgate] open Let the fish go upstream....Reconnect the pa to the river”

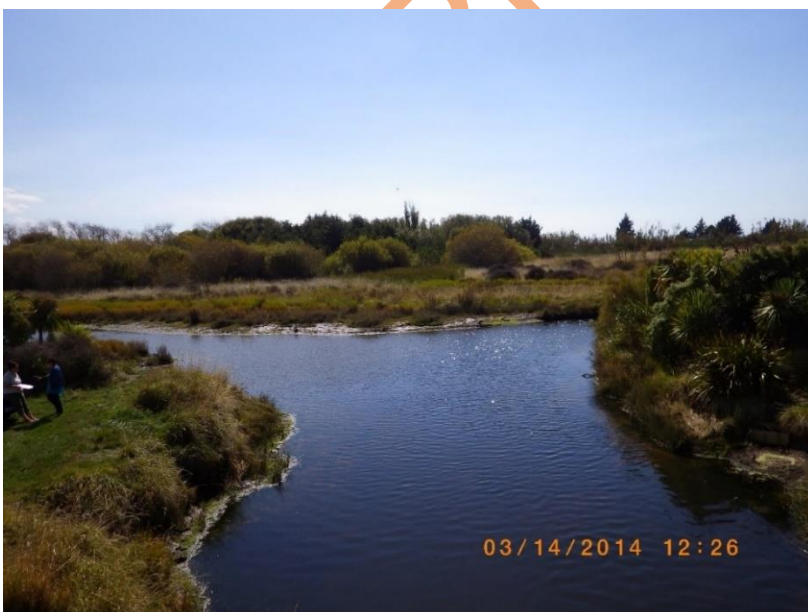
Looking below the floodgate to the channel

- Whanau are concerned at the lack of passage upstream
- This area is an important area for whitebait. Restoring access for fish species to their spawning sites upstream in the Taranaki Stream is recommended

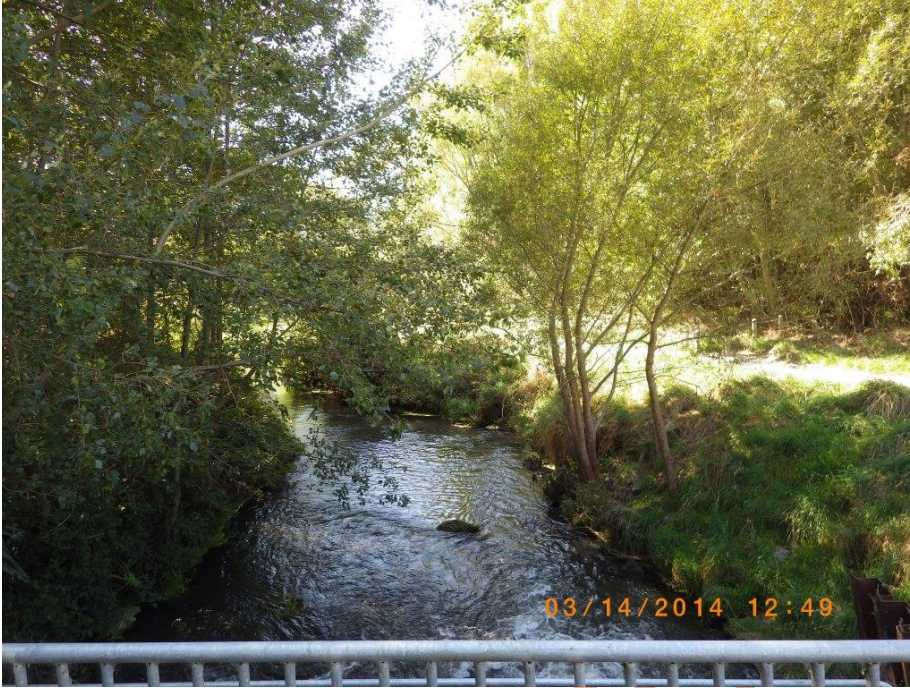
Looking downstream

- Water appears clear
- Good flows are observed but it is unclear if these are augmented by irrigation – if they are, are the waters nutrient enriched?

- Maintain reliable year round stream flows.
- Investigate water quality to determine nutrient levels.
- Ensure high quality water quality

- Minimise sediment inputs and impacts from adjacent landuse. Fence off the riparian margin. Plant with indigenous species.
- Investigate the effect of the culvert, under different flow regimes, to ensure that it is not a barrier to fish passage.
- Continue to implement with Te Ngai Tuahuriri Runanga the agreed drain cleaning protocol

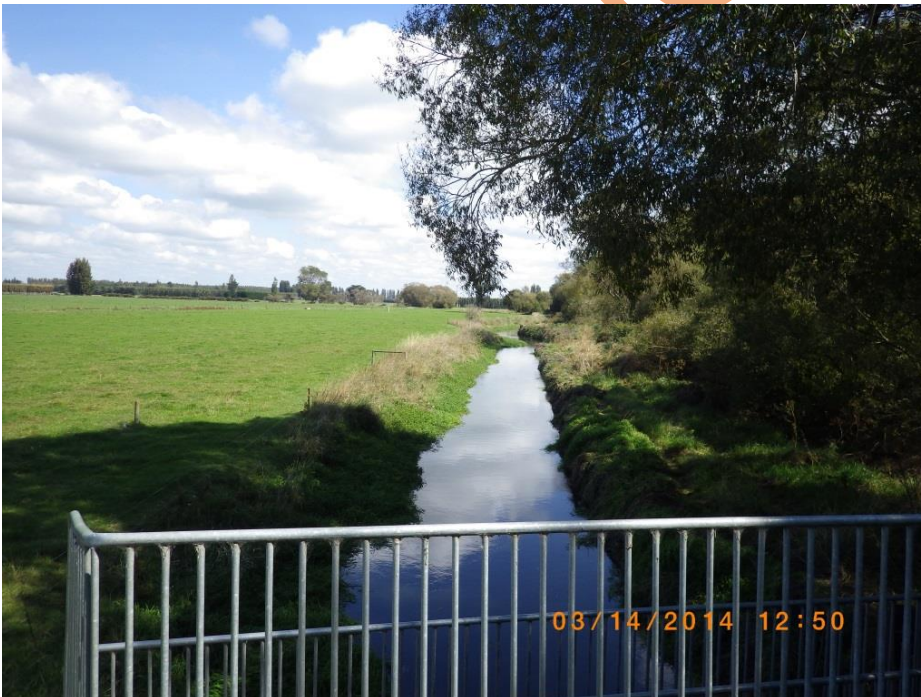
Looking upstream

- A greater buffer between the stream and adjacent landuse is needed. It should be planted appropriately.

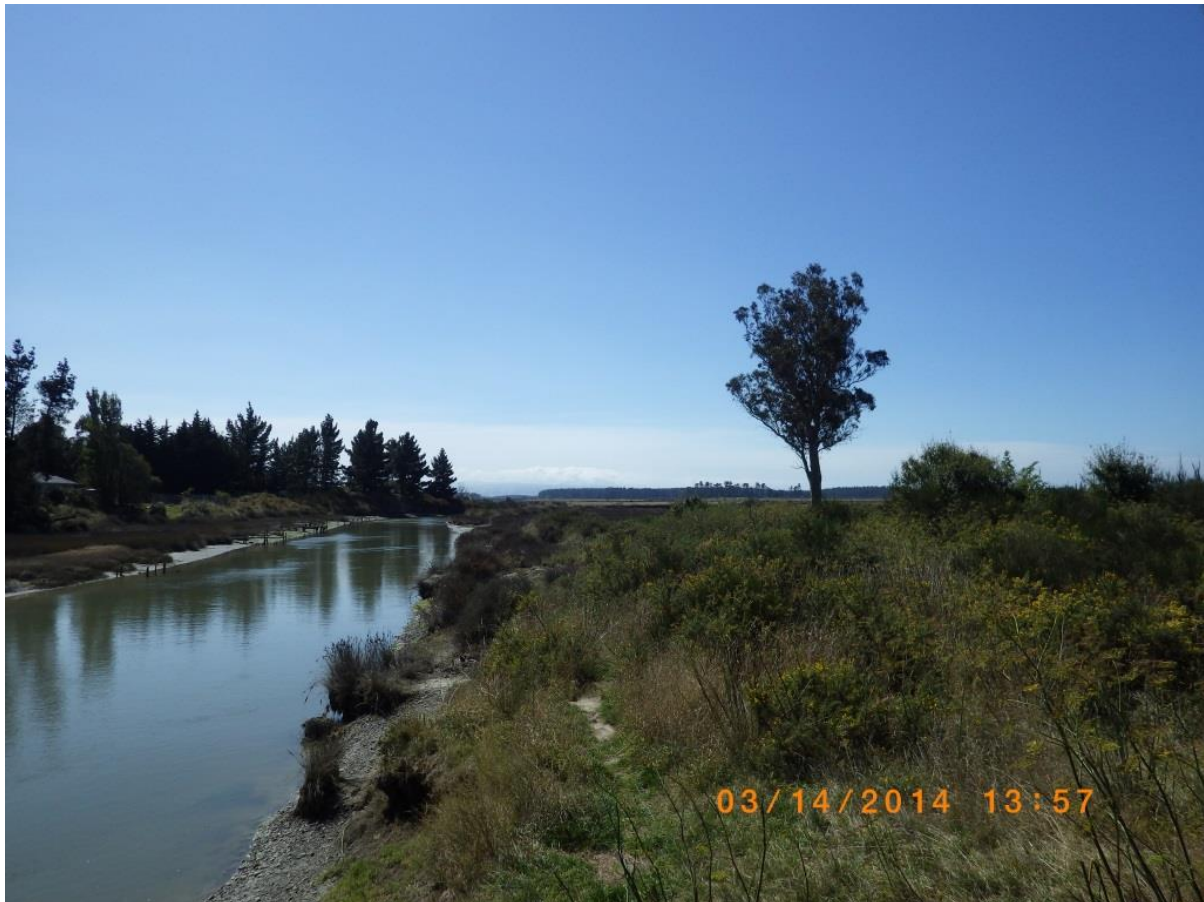
- It is a modified watercourse that carries natural waters.
- It receives a below average mahinga kai score and a poor health score.
- The degraded state of the stream makes it unattractive to gatherers and it is potentially unsafe for them to gather.
- All health indicators scored poorly.

Looking downstream - A range of initiatives are needed to restore this site. It remains an important tributary that once sustained cultural use.

- Prioritise managing this site as a mahinga kai.
- Enhance water quality
- Minimise sediment inputs and impacts from the eroding bank. Erosion mitigation strategies need to be agreed with Ngai Tuahuriri.
- Investigate the extent of recent reclamations around the estuary. Identify the depth of the buffer between the creek and adjacent landuses, and between the estuary and adjacent landuses.
- Extend the current planting programme.
- Monitor water quality, which will include ongoing cultural monitoring. This is to ensure that water is not nutrient enriched.
- Continue to implement with Te Ngai Tuahuriri Runanga the agreed drain cleaning protocol
- Remove the remnants of the jetty
- Provide rubbish bins and toilets to eliminate the risk of informal dumping of waste.

- Remove the remnants of the jetty
- Develop a protocol (jointly with Te Ngai Tuahuriri Runanga) for the use of machinery such as diggers in close proximity to the estuary.
- Investigate the flow needs of fish in the stream and estuary

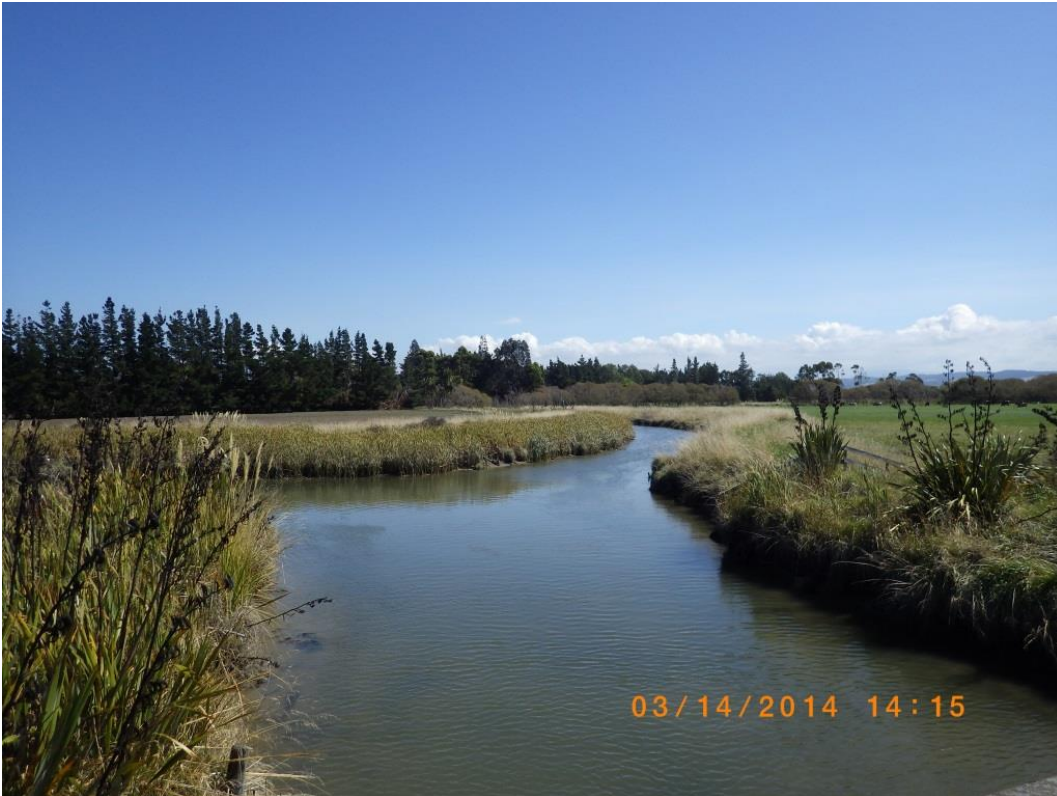
Looking upstream

- There is Harakeke and Raupo planted. But a greater buffer between the stream and adjacent landuse is needed. It should be planted appropriately.

- Weed control is needed.
- Investigate connections to other estuary.
- Minimise sediment inputs and impacts from adjacent landuse through retention of a sizeable buffer that is planted with indigenous shrubs and trees.
- Land intensification in the lower catchment needs to be controlled.

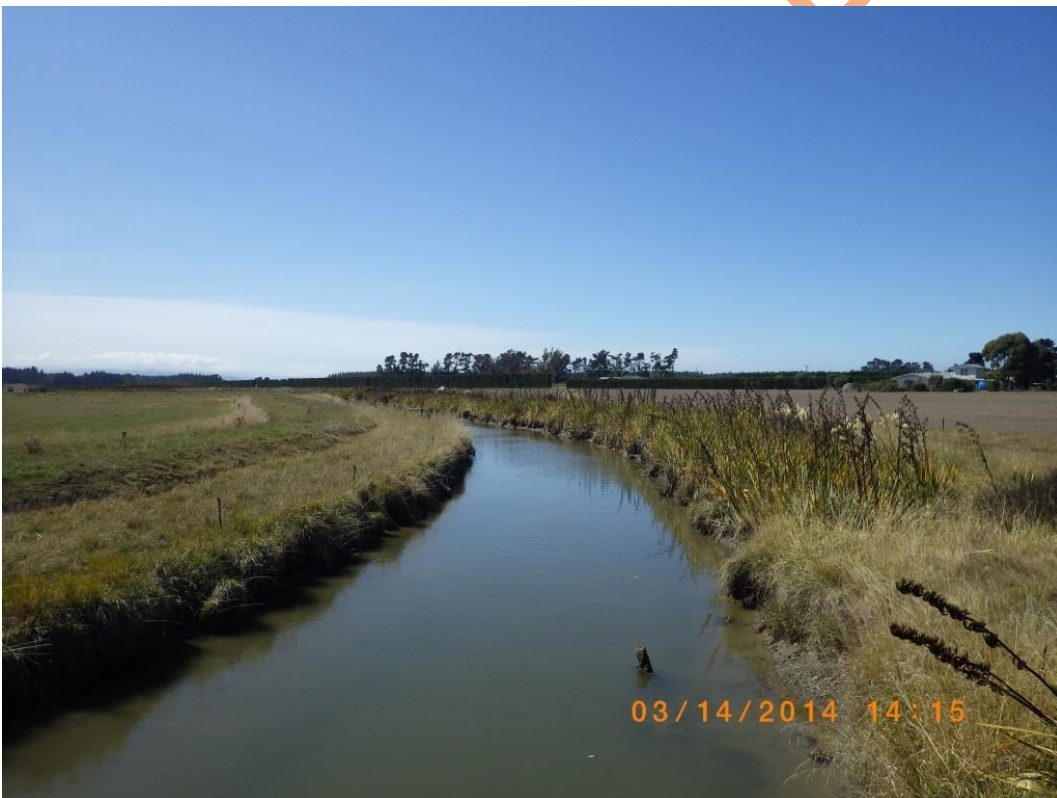
Looking downstream

- A planted greater buffer between the stream and adjacent landuse is needed. It should be planted appropriately.

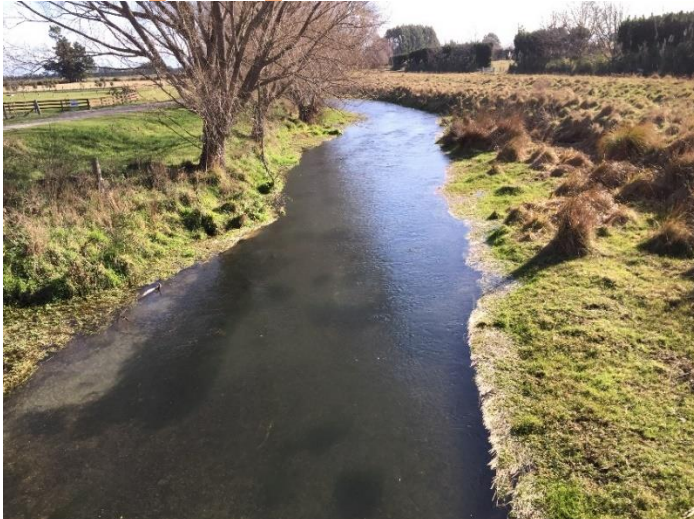
WATER QUALITY	RECREATION
<p>Water quality is decreasing</p> <ul style="list-style-type: none"> • Failed to meet target for total fine sediment cover 2013-2015. • Failed to meet average for total fine sediment cover. • Target for maximum temperature met. • Target for dissolved oxygen saturation met. • TSS is not an issue at this site. 	<ul style="list-style-type: none"> • Met the LWRP target for cyanobacteria. There is not a health risk from cyanobacteria. • For e-coli the MFE/MOH action level of 550 was breached.

- Failed to meet the LWRP target for QMCI in 2011 - 2014.
- Failed to meet the LWRP target for average QMCI
- Failed to meet target in LWRP for total macrophyte cover once
- Met target for emergent macrophytes

The Cam River - looking upstream at Bramley Road

- Protect water quality.
- Investigate the quality of the water to ensure that it is safe for gathering. Whanau want to reconnect with this site and their safety has to be paramount.
- Maintain good flows in the stream.
- Riparian planting is needed, especially natives that attract birdlife.
- Minimise impacts from adjacent landuse by establishing a larger buffer zone that is planted and fenced off. Stock are to be excluded.
- Investigate the impact of culverts and floodgates on fish populations.
- Monitor water quality, which will include ongoing cultural monitoring. This stream is fed by a natural spring. Whanau so not want to see the waters nutrient enriched.
- Continue to implement with Te Ngai Tuahuriri Runanga the agreed drain cleaning protocol.

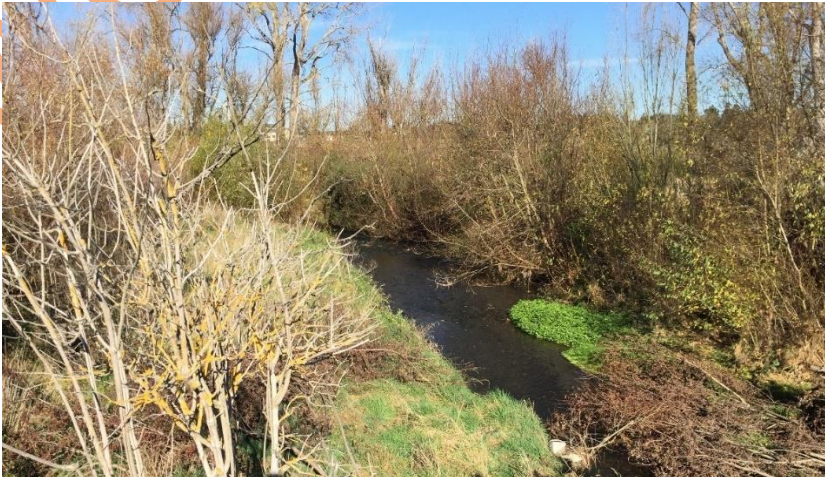
WATER QUALITY	RECREATION
<ul style="list-style-type: none"> Nitrate N in the groundwater around Cust is the highest in the zone. Met the target for total fine sediment cover 3 out of five years Failed to meet the target for the average for total fine sediment cover Target for maximum temperature met target. Target for dissolved oxygen saturation met. TSS is not an issue at this site. Median DIN and DRP far exceed thresholds for protection of biodiversity. DIN exceeds 90% probability of nuisance growths 	<p>MFE/MOH “alert guideline” for cyanobacteria breached 2014 and 2015.</p> <p>Average for cyanobacteria meets target.</p>

- Failed to meet the LWRP target for QMCI 2011-2015
- Failed to meet the LWRP target for mean QMCI
- Met target in LWRP for total macrophyte cover
- Met target for emergent macrophyte cover

The Cust - looking downstream

- Improve water quality. Address high nutrient levels.
- Investigate the quality of the water to ensure that it is safe for gathering. Whanau do use this site and their safety has to be paramount.
- Maintain good flows in the stream.
- Improve access to the stream by whanau.
- Riparian planting is needed. Remove willows and replant.
- Increase the minimum flow. Include a “step up” if the minimum is breached.
- Minimise impacts from adjacent landuse by establishing a larger buffer zone that is planted and fenced off. Stock are to be excluded.
- Investigate to see if the kai in the stream is safe to eat.
- Monitor water quality, which will include ongoing cultural monitoring. This stream is fed by a natural spring. Whanau so not want to see the waters nutrient enriched.
- Continue to implement with Te Ngai Tuahuriri Runanga the agreed drain cleaning protocol

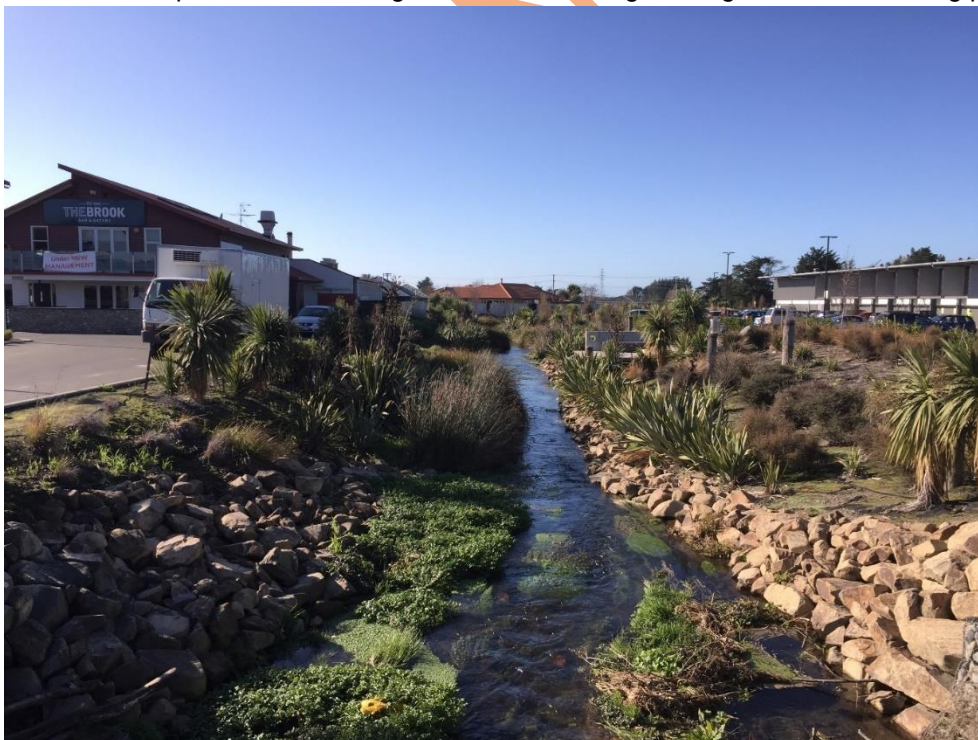
WATER QUALITY	RECREATION
<p>Water quality is decreasing</p> <ul style="list-style-type: none"> Failed to meet target for total fine sediment cover 2 of the last five years Failed to meet the average for total fine sediment cover Target for maximum temperature met Target for dissolved oxygen saturation met. TSS is not an issue at this site. DIN – high – exceeds the 90% probability of nuisance macrophyte growth 	<p>Met the LWRP target for cyanobacteria. Perceived to be no health risk.</p> <p>Ecoli – the MFE/MOH “action trigger” of 550 has been breached.</p>
MCI & MACROPHYTES	
<ul style="list-style-type: none"> Failed to meet the LWRP target for QMCI 2011- 2015. Failed to meet the LWRP target for mean QMCI Failed to meet target in LWRP for total macrophyte cover twice since 2011 Met the mean target LWRP for total macrophyte cover Met target for emergent macrophytes

Looking downstream – the replanted reach of the SouthBrook

- Protect water quality.
- Investigate the quality of the water to ensure that it is safe for gathering.
- Set a minimum flow for this stream.
- Riparian planting is needed.
- Identify if there are any legacy contamination issues from runoff from the township.
- Minimise impacts from adjacent landuse by establishing a larger buffer zone that is planted and fenced off.
- Monitor water quality, which will include ongoing cultural monitoring. This stream is fed by a natural spring. Work with whanau to identify and protect the springheads.
- Continue to implement with Te Ngai Tuahuriri Runanga the agreed drain cleaning protocol
