CULTURAL HEALTH ASSESSMENTS & WATER MANAGEMENT FOR THE RAKAHURI – WAIMAKARIRI ZONE

Prepared by Representatives of Te Ngai Tuahuriri and Tipa
& Associates

October 2016

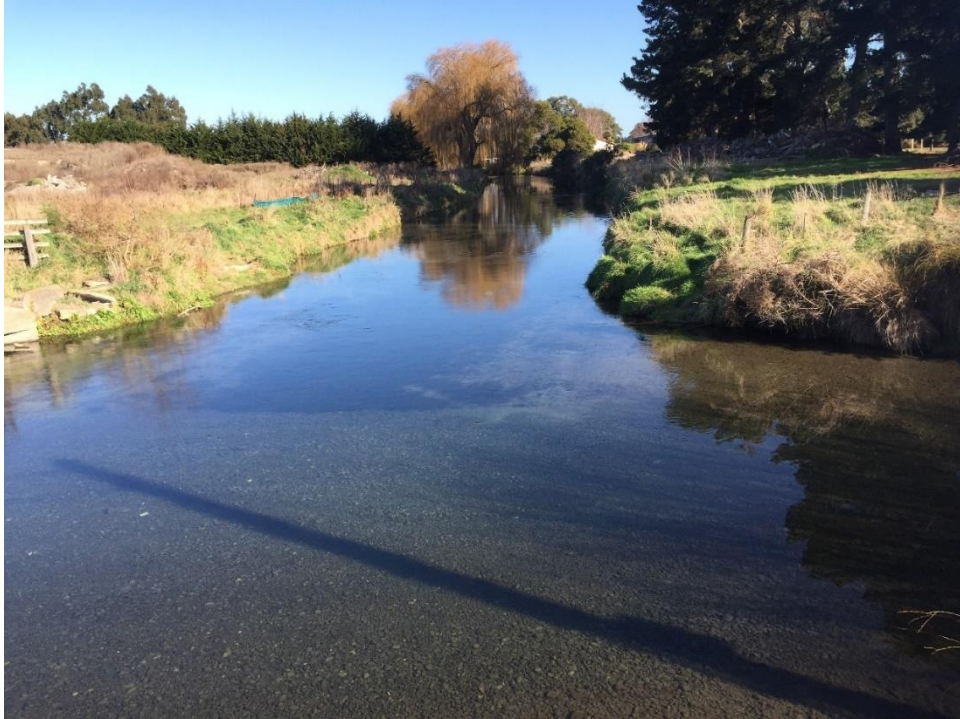
Looking upstream at the Silverstream – the ford where 4WD are washed.

- Protect water quality.
- Investigate the quality of the water to ensure that it is safe for gathering. Whanau do use this site and their safety has to be paramount.
- Maintain good flows in the stream.
- Riparian planting is needed.
- Monitor water quality, which will include ongoing cultural monitoring. This stream is fed by a natural spring. Whanau so not want to see the waters nutrient enriched.
- Continue to implement with Te Ngai Tuahuriri Runanga the agreed drain cleaning protocol

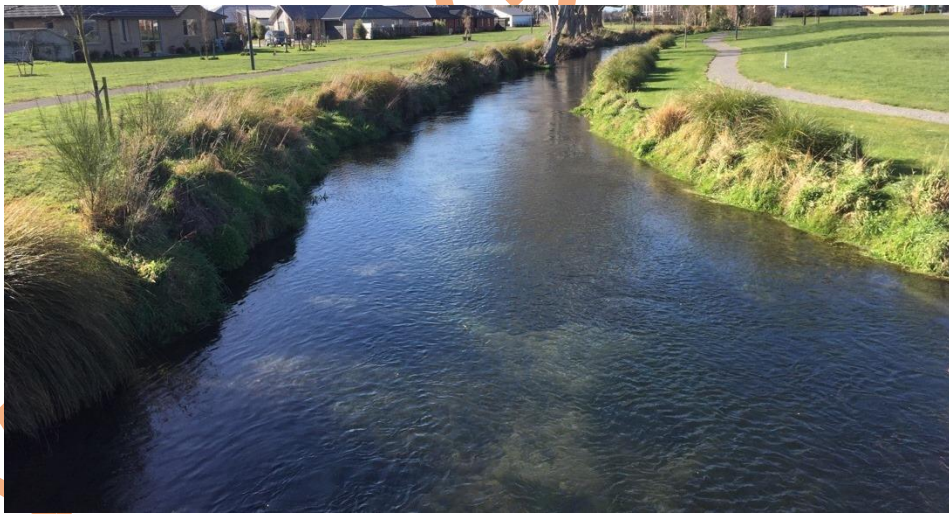
Looking downstream at the Silverstream – the site where whanau have not seen fish life.

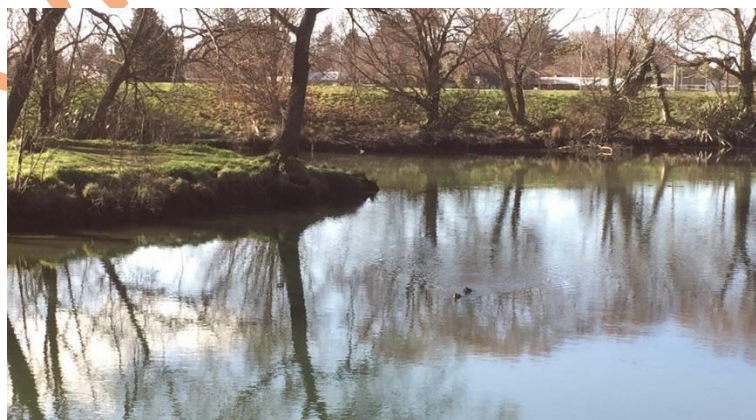
The Floodgate where the Cam meets the Kaiapoi is an issue for whanau.

- Improve water quality.
- Remove trees that have died and replant with salt tolerant native plants.
- Maintain health flows in the stream consistent with whanau provisions.
- Minimise impacts from adjacent landuse by establishing a larger buffer zone that is planted and fenced off. Stock are to be excluded.
- Monitor water quality, which will include ongoing cultural monitoring.
