Scoping strategy for the Three Brooks and channel enhancements in the middle Cam River and Tuahiwi Drain

Prepared for Waimakariri District Council
Prepared by Dr Henry R Hudson
Environmental Management Associates
Nelson
(+64) 027 284 4239

*Report 17-04
April 2017*

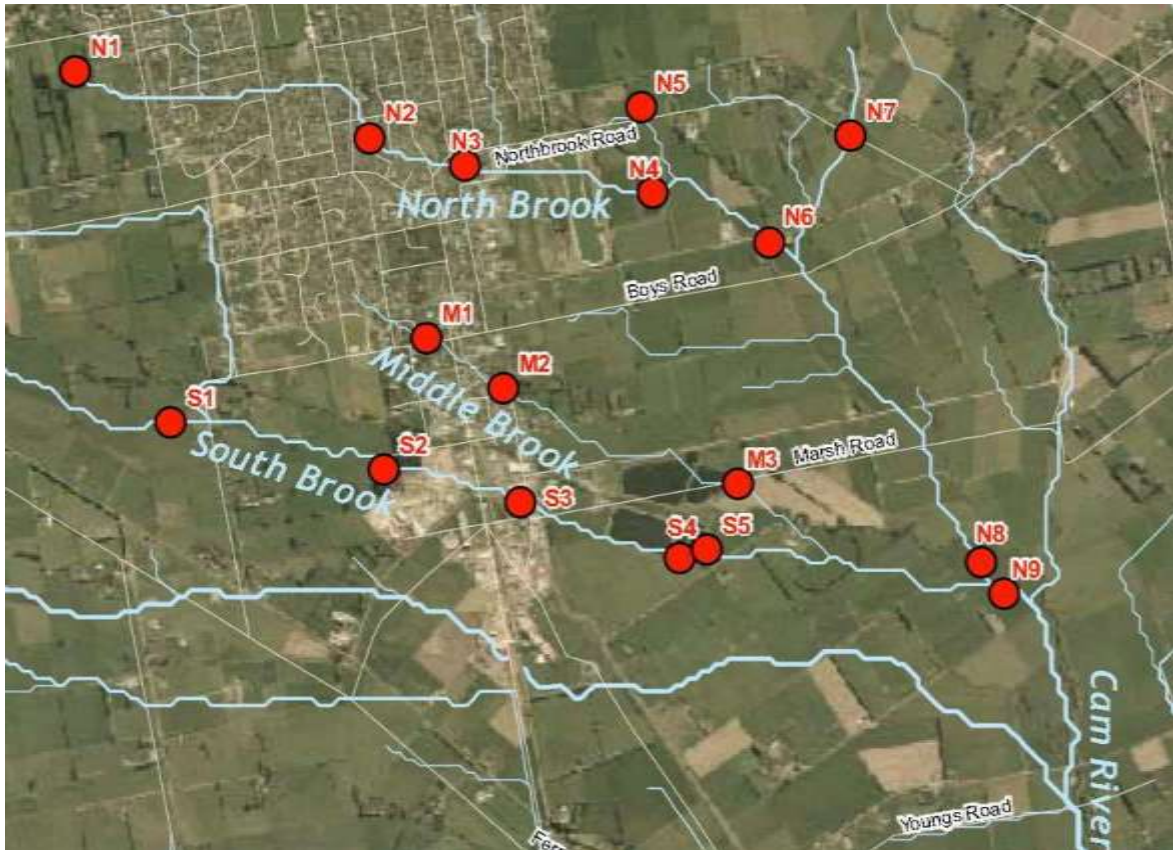
Figure 2 Three Brooks sampling sites (based on Golder Associates 2008)

Hudson (2010) looked at patterns of ecological values with habitat suitability criteria (substrate, depth and velocity) and found some obvious relations such as N1 site at North Brook has unsuitable depth and velocity and 80% fine sediment cover which is unsuitable for high quality macroinvertebrates. In contrast, the 7 top ranked sites had depths ranging from 0.25 to 0.35 m and velocities of 0.80 to 1.00 m/s and ~5 to 15% fine sediment. The concluded these relations strongly suggest the most productive sites have riffle like characteristics with shallow fast flows over a clean gravel bed, a known characteristic of good benthic invertebrate habitat (e.g. Jowett & Richardson 1991).

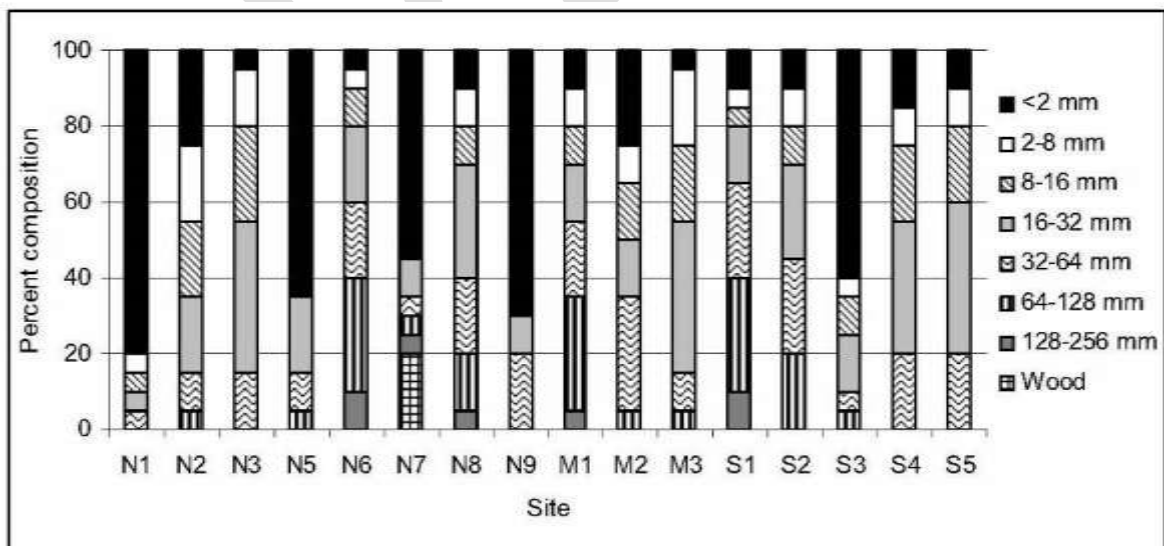
Figure 3 Composition of stream bed sediments in the Three Brooks (see Figure 2 for locations; Golder Associates 2008)

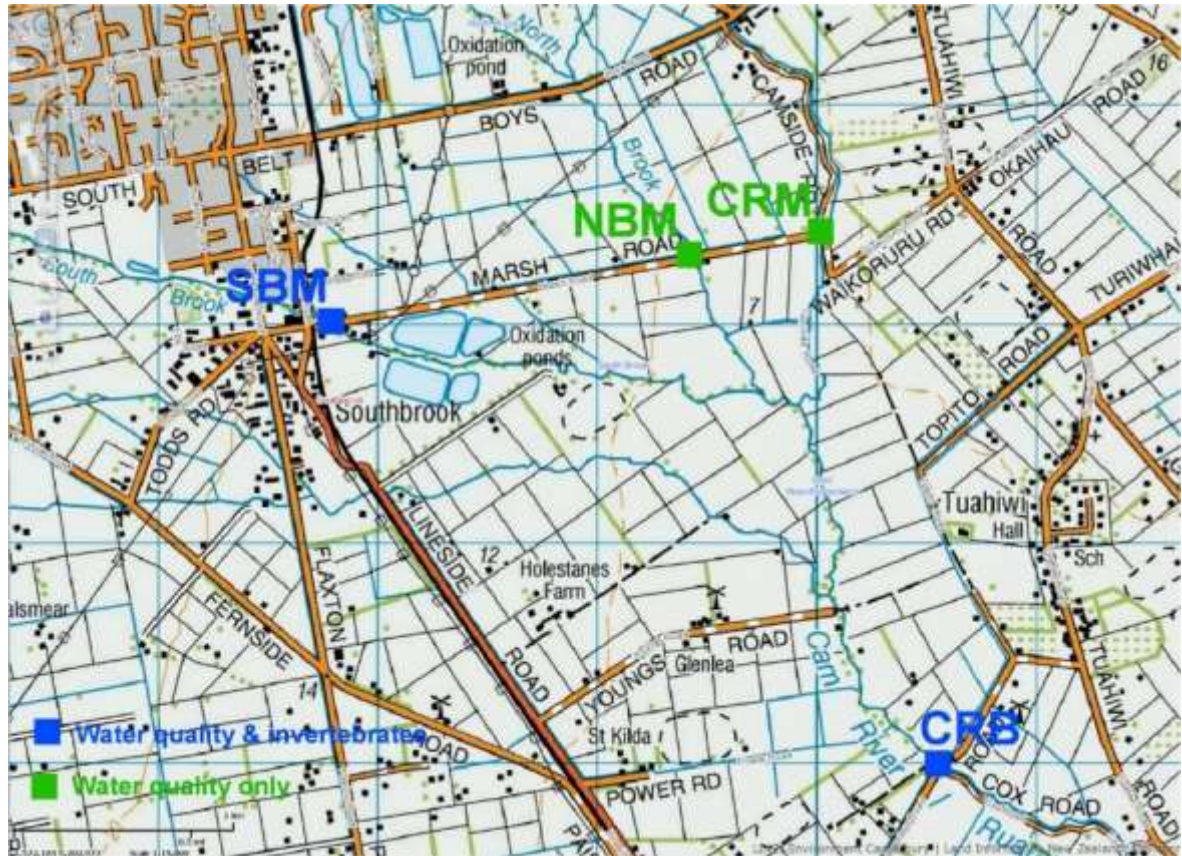
- SQ34905 Cam River at Marsh Rd (CRM)
- SQ30369 Cam River at Bramleys Road (CRB)
- SQ34903 North Brook at Marsh Rd (NBM)
- SQ30390 South Brook at Marsh Rd (SBM)

Figure 4 ECan sampling sites (based on Greer & Meredith 2016)

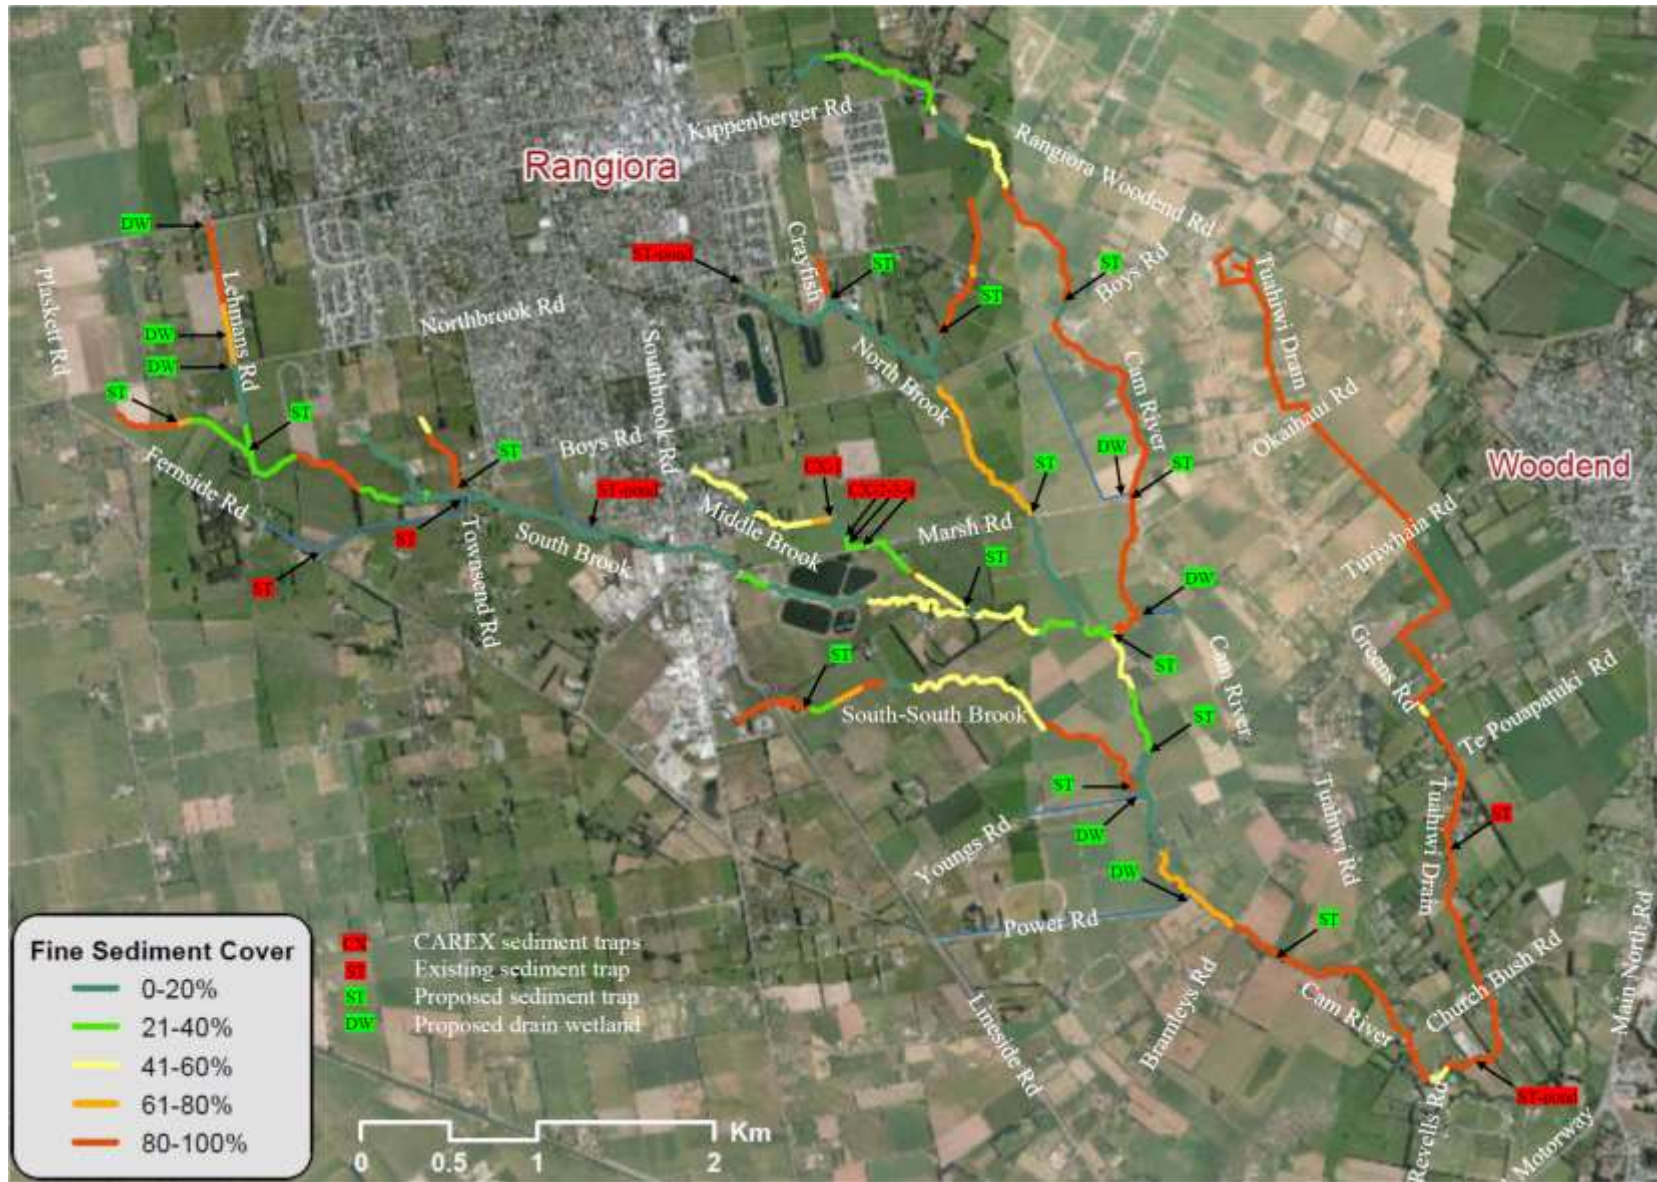
Figure 5 Fine sediment cover (map kindly provided by ECan) proposed & existing sediment traps & drain wetlands

- All of South-South Brook (a small reach was not assessed); and
- All of Tuahiwi Drain.
- There are subtleties within the fine sediment patterns in a figure titled Fine Sediment Cover that was provided earlier by ECan. Cover is reported in 5 classes in Figure 5: 0-20%; 21-40%; 41-60%; 61-80% and 81-100%. This detail is useful in identifying reaches for remedial works or to prevent further downstream degradation with sediment traps (Figure 5). In this regard:

- Cam River: Most of the Cam above the Three Brooks confluence has 80-100% fine sediment cover; The segment from the Three Brooks to Bramleys Road has a sub-equal mix of the 0-20 to 61-80% fine sediment cover. To protect the higher quality reaches from upstream resuspension and transport of fine sediment, sediment traps are recommended on the Cam near Boys Road, Marsh Road, near the Three Brooks confluence, and at the South-South Brook confluence (the latter combined with a wetland);

- North Brook: Two tributaries above Boys Road have 61-80% fine sediment cover as does the reach between Boys and Marsh Road. The remainder of the Brook is high quality. A sediment trap is recommended at Marsh Road, and also in the main tributary above Boys Road;

- South-South Brook: The upper ~460 m and lower ~725 m have >80% fine sediment cover; with short segments of mixed cover, with 41-80% fine sediment cover dominating (~950 m ~35% of the total length surveyed); a sediment trap at the confluence with the Cam is recommended; and

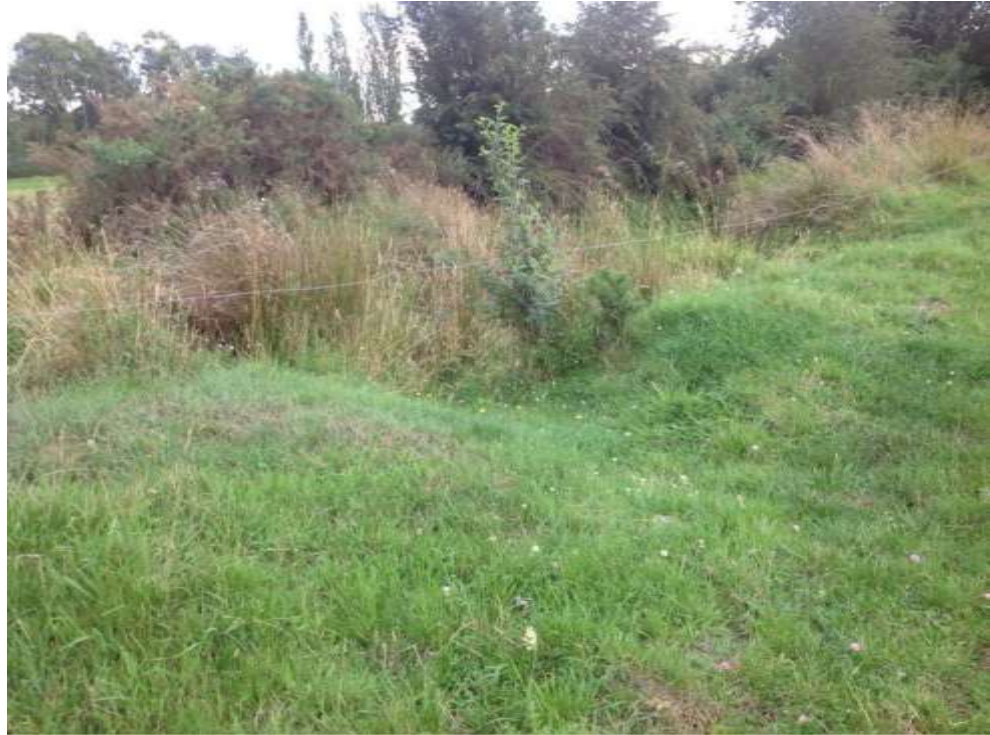
Figure 6 Overland flow path for land surface drainage, North Brook tributary 1 at R1 in Figure A3: 2A (ECan streamwalk)

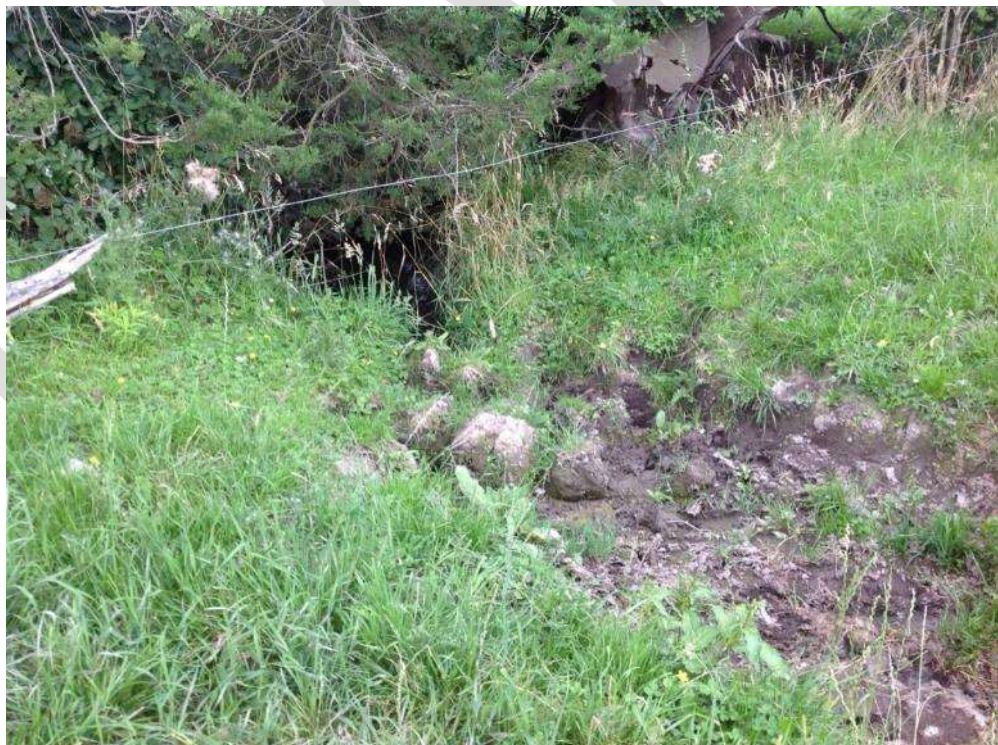
Figure 7 Overland flow path for land surface drainage, North Brook tributary 1 at R4 in Figure A3: 2A (ECan streamwalk)

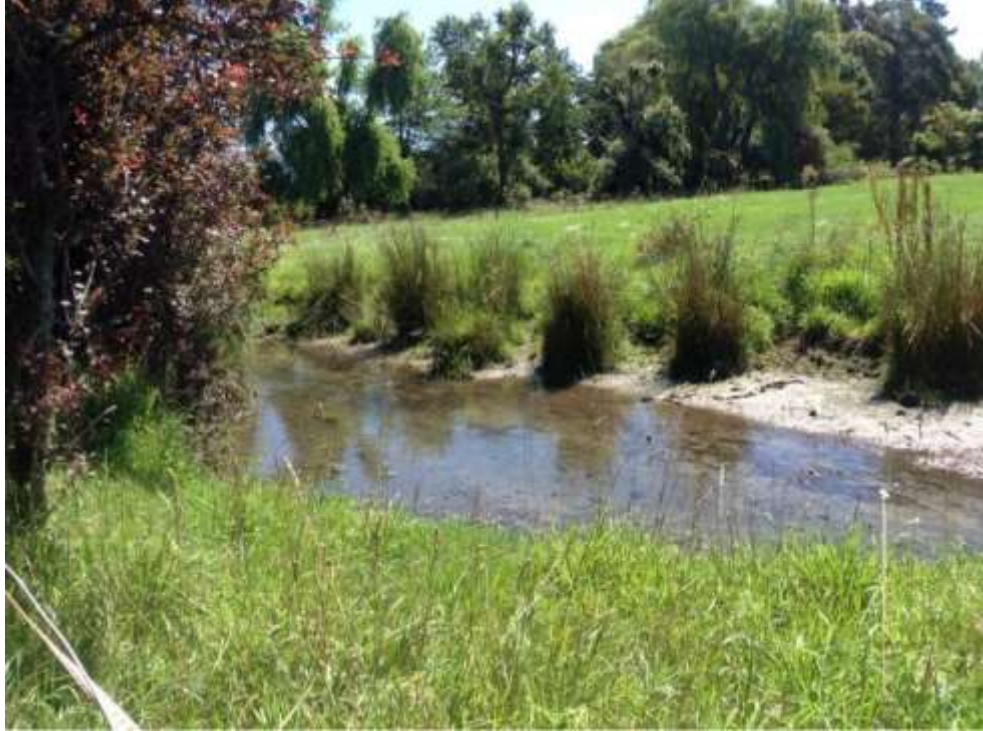
Figure 8 Stock trampling bank collapse, view upstream Middle Brook above Dunlops Road at R15 (ECan streamwalk)

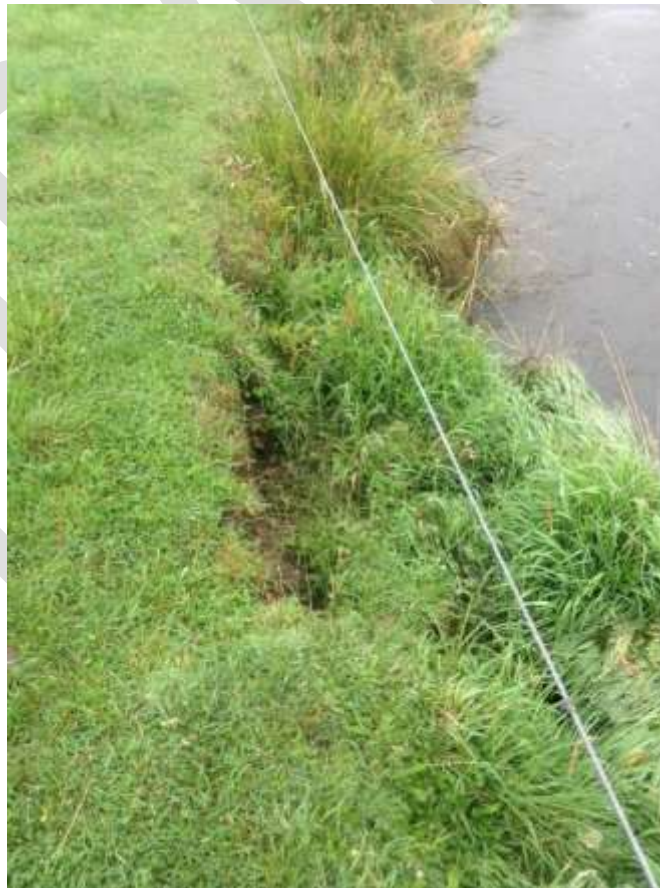
Figure 9 Toe scour and collapse, North Brook above Marsh Road at R4 in Figure A3: 2A (ECan streamwalk)

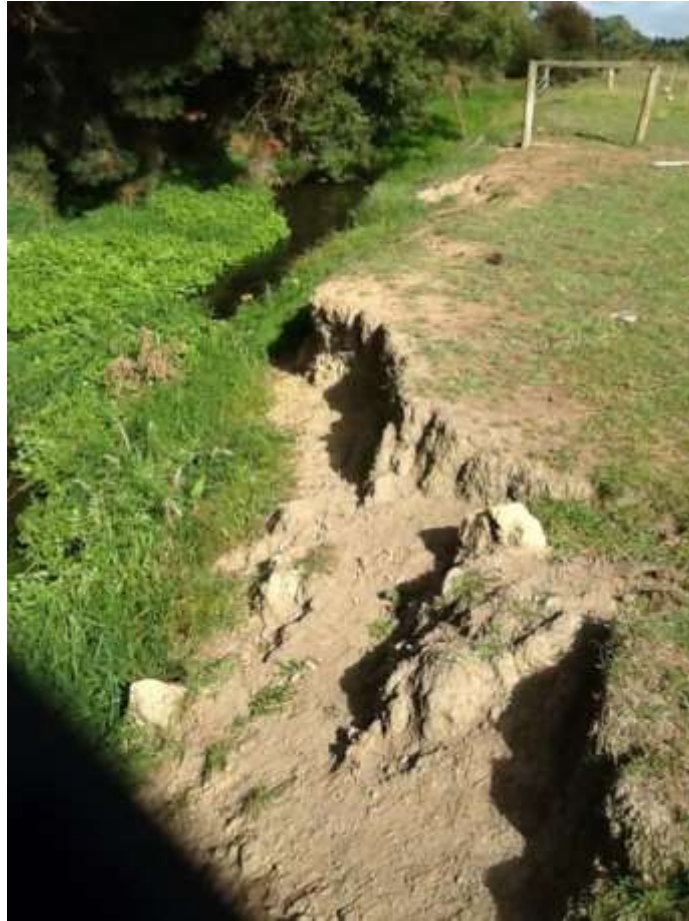
Figure 10 Over steepened banks can erode by dry ravel, South Brook above Buckleys Road at R22-23 (ECan streamwalk)

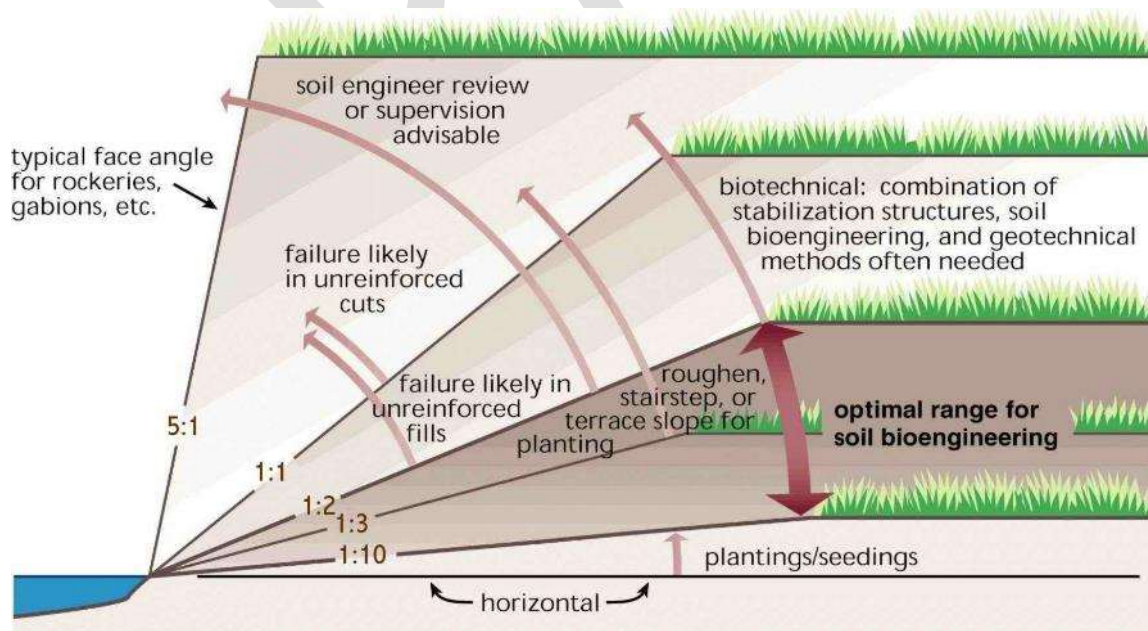
Figure 11 Bank reshaping: guideline (FISRWG 1998)

Comment Slope (rise/run), and bank height relative to rooting depth, are important factors in determining appropriate bank protection measures.

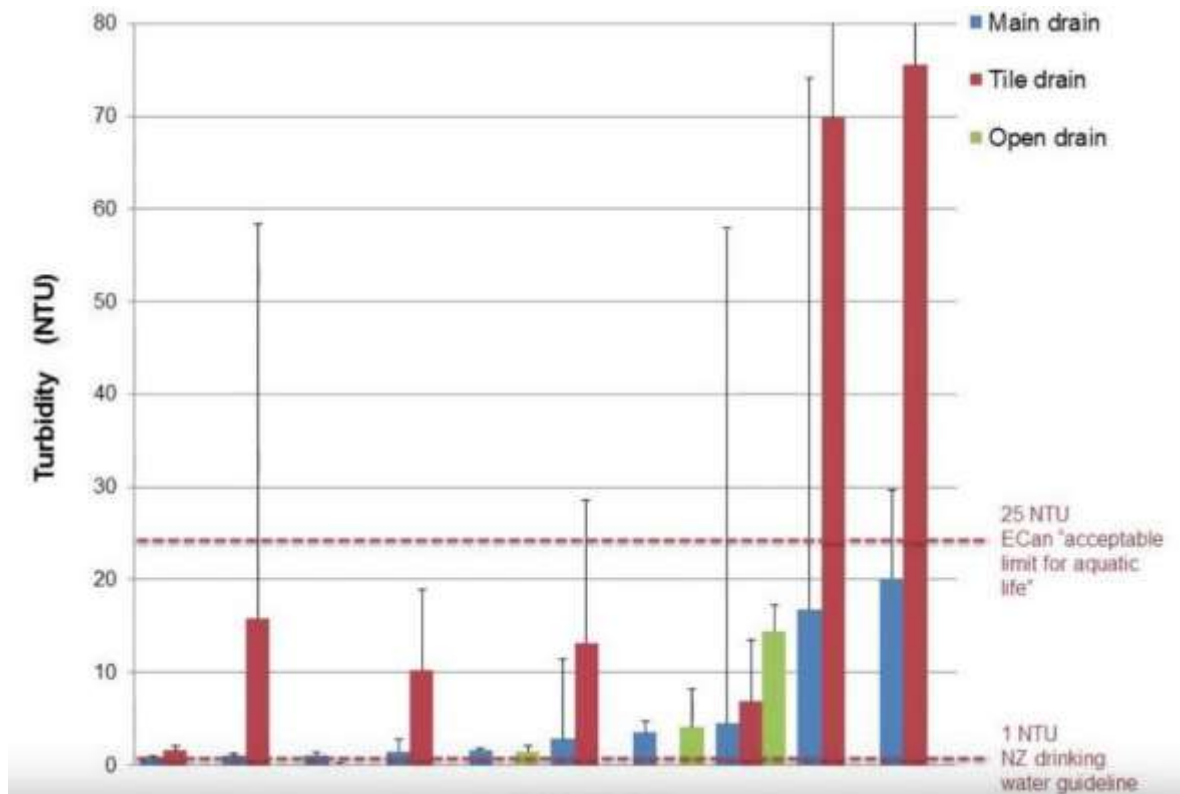
Figure 13 Tile drains may be a source of sediment (and contaminants) (source: McIntosh 2016)

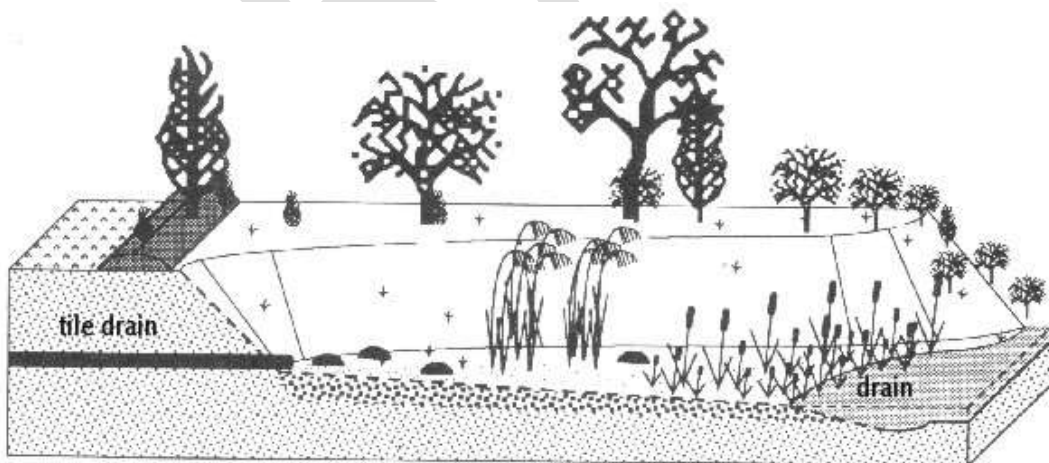
Figure 14 Schematic of a mini-wetland that receives water from tile drains and acts as a sediment and nutrient trap (adapted from Petersen et al. 1992)

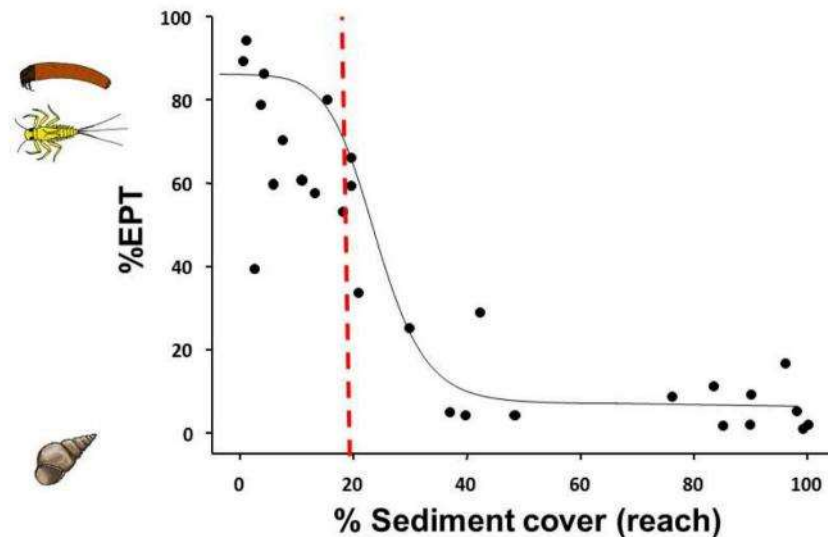
Mayflies, stoneflies and caddisflies can be negatively impacted by deposited fine sediment bed cover exceeding approximately 20%, and that legacies of long-term sediment can prevent recovery even when sources are controlled.

Figure 15 Fine sediment cover threshold (CAREX poster-2)

Comment: The recommended guideline for fine sediment (<2 mm) cover for macroinvertebrates and fish is 20% (Clapcott et al. 2011).

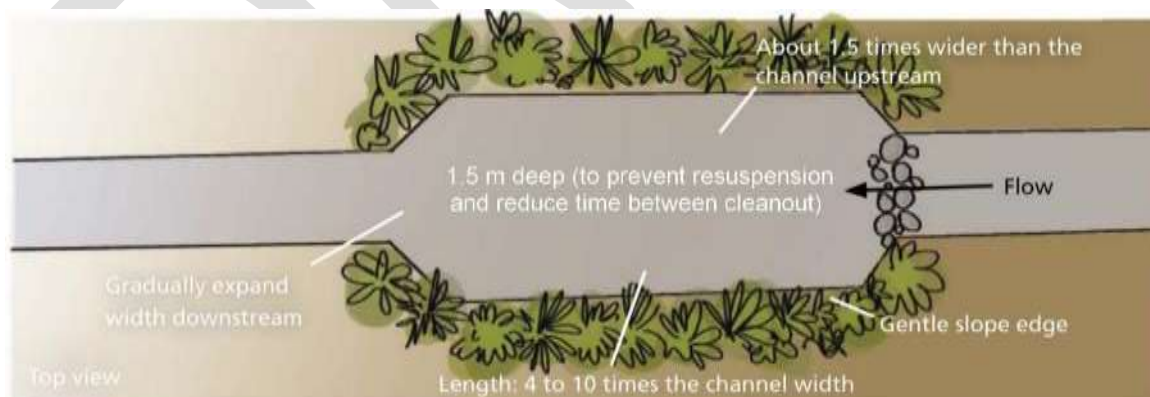
Figure 16 Conventional sediment trap rule of thumb design (after Hudson 2002)

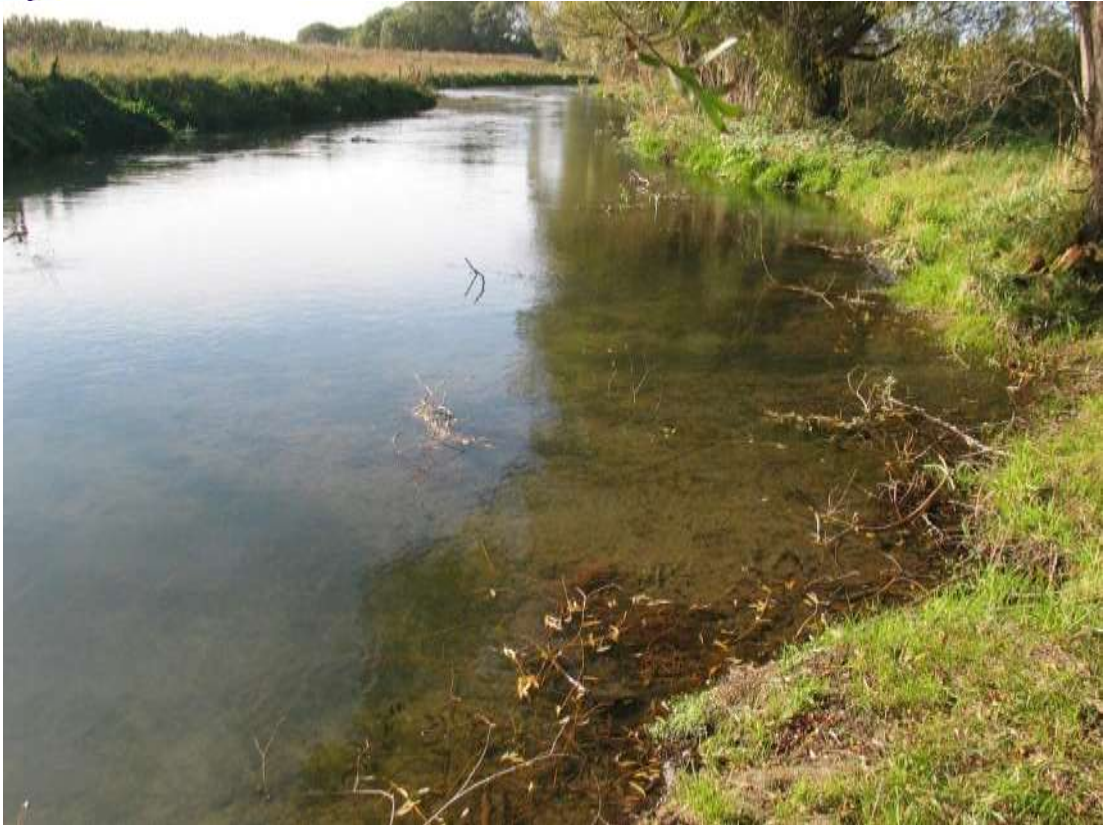
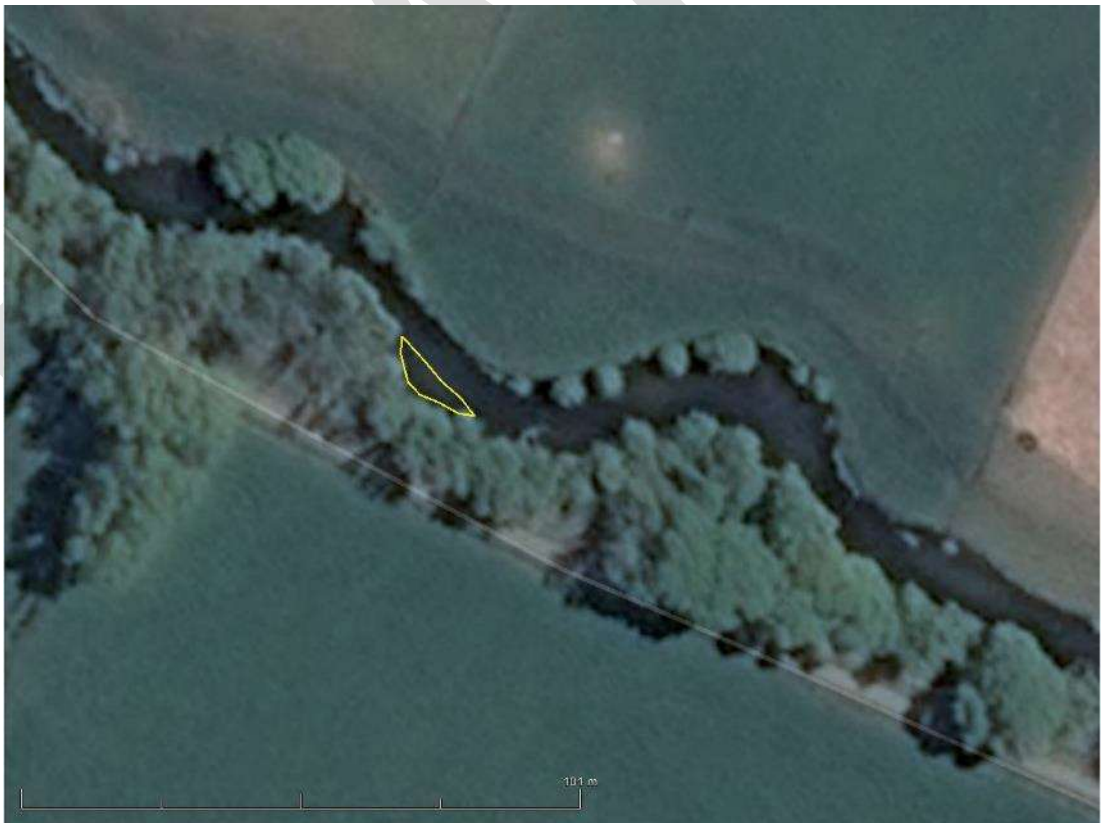
Figure 17 Natural sediment deposition areas can be utilised as sediment traps by removing sediment to revitalise deposition (Cam River ~300 m below Bramleys Road)

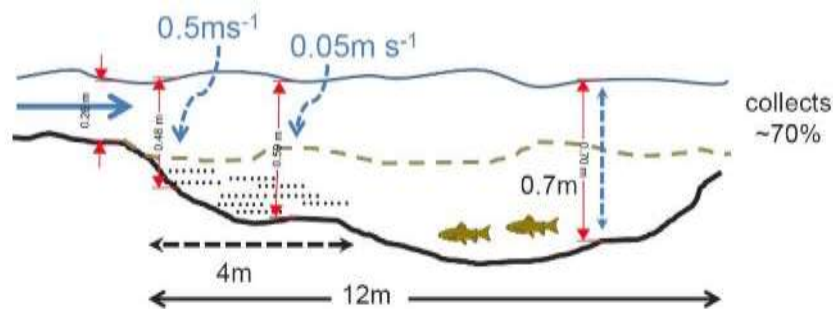
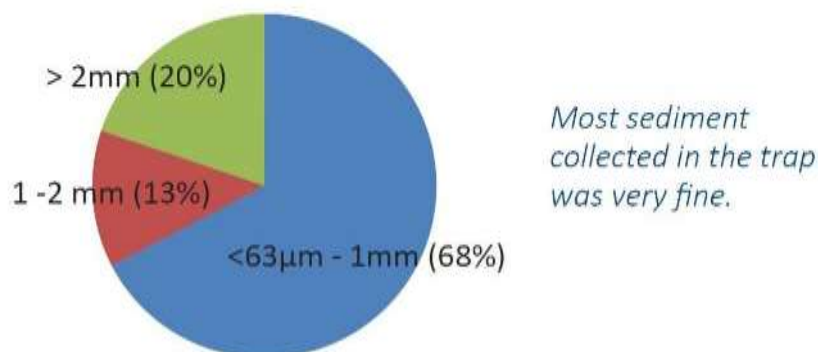
Recently, we used a digger to clean out our large (12m long and 0.7 m deep) sediment trap, which has been in place for 8 months. One of our students was monitoring the amount of sediment collected in the trap and we estimate it has captured about 60-70% of the fine sediment entering this length of stream. Over the 8 month period, the trap filled in to an average depth of ~35cm deep. During our cleaning we removed about 4m³ of sediment from the trap! The trap has proven to be very efficient and its success is due to it being long enough and deep enough to reduce the water velocity to less than 0.01m/s¹. This very slow water velocity is enough for very fine silt to drop out of the water column. We will continue to monitor this trap and several others over the next year. Our aim is to develop an "ideal" sediment trap design.

The trap collected 60-70% of the fine sediment entering the reach over a 8-month period. The theoretical trap efficiency for this trap is about 95% for 125 μm sediment based on Hudson (2002).

Figure 18 CX-01 sediment trap (CAREX newsletter Sep 2015 (a - top); CAREX poster 2 (Harding et. al. undated) (b - bottom)

Comment: In the text the trap velocity is reported as less than 0.01 m/s; but the figure below has a trap velocity of 0.05 m/s and input velocity of 0.5 m/s. For the reported cross sectional area of 1.75 m³ (2.5 m width and 0.7 m depth), to achieve a 0.01 m/s mean velocity requires a streamflow of less than 20 L/s which is far less than expected (75 to 560 L/s - see footnote 16). There should be no gain or loss of flow.

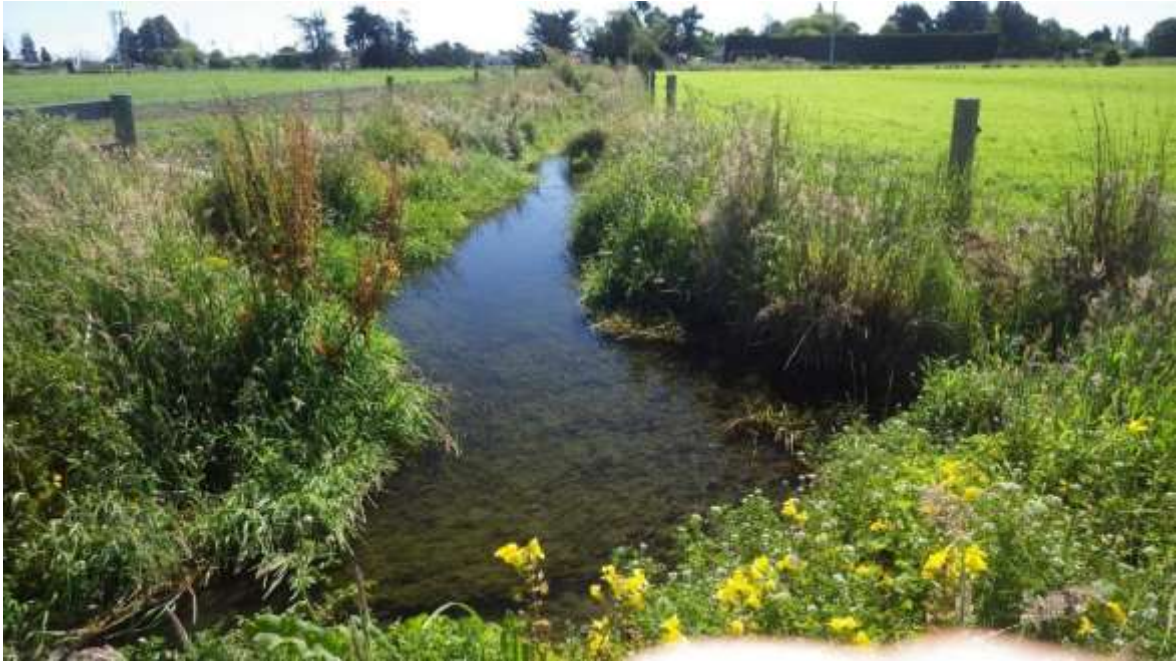
Figure 19 Main CAREX sediment trap on the Middle Brook ~400 m upstream of Marsh Road (CX-01 in Figure 5)

Comment: The trap is largely infilled with fine sediment. Some trapping will continue within the vegetation, but this material is easily resuspended with agitation. View upstream.

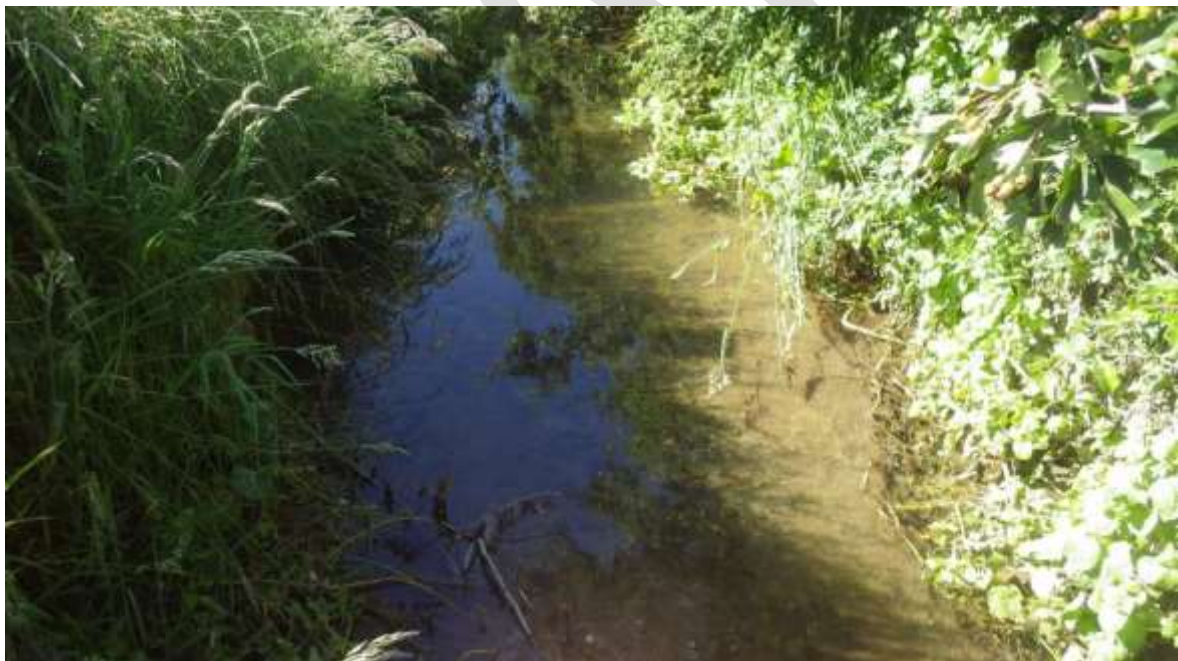
Figure 20 CAREX shallow sediment trap on the Middle Brook ~240 m upstream of Marsh Road (ST-CX-02 in Figure 5)

Comment: View upstream. Trapping occurs along the edge of the shallow trap (where silt plates are located), but the bed is largely exposed gravel indicating the trap is too shallow to be effective. It is unclear how edge silt plates are used to calculated sediment loads and trap efficiencies.

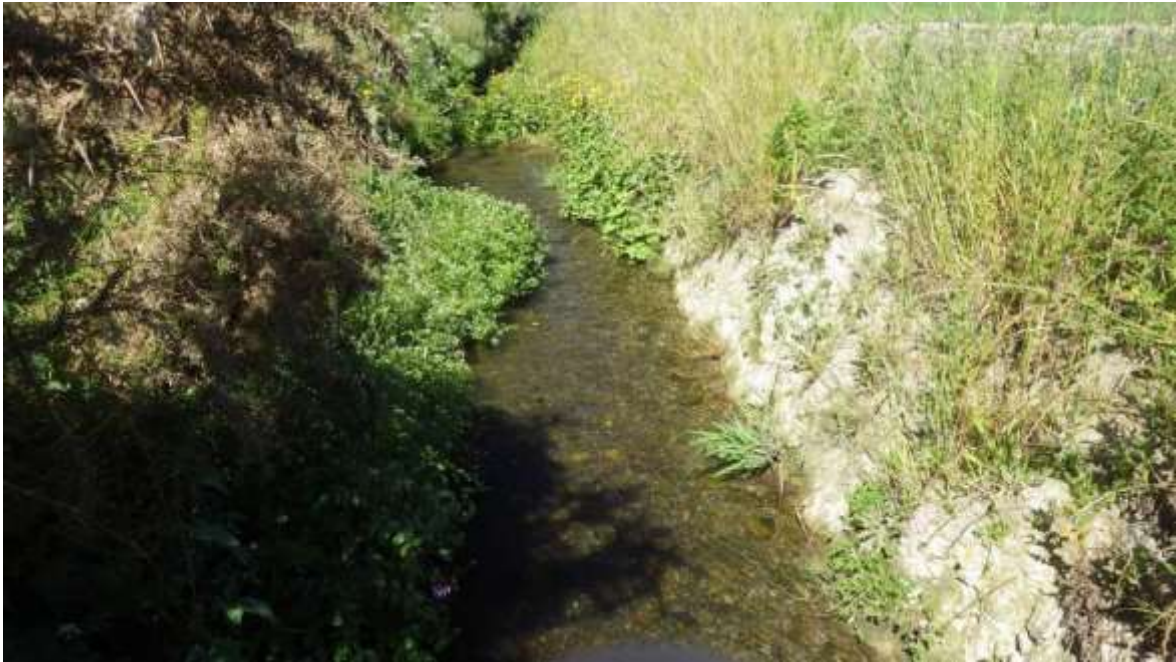
Figure 21 Middle Brook below the main CAREX sediment trap is a clean gravel bed (ST-CX-01 in Figure 5)

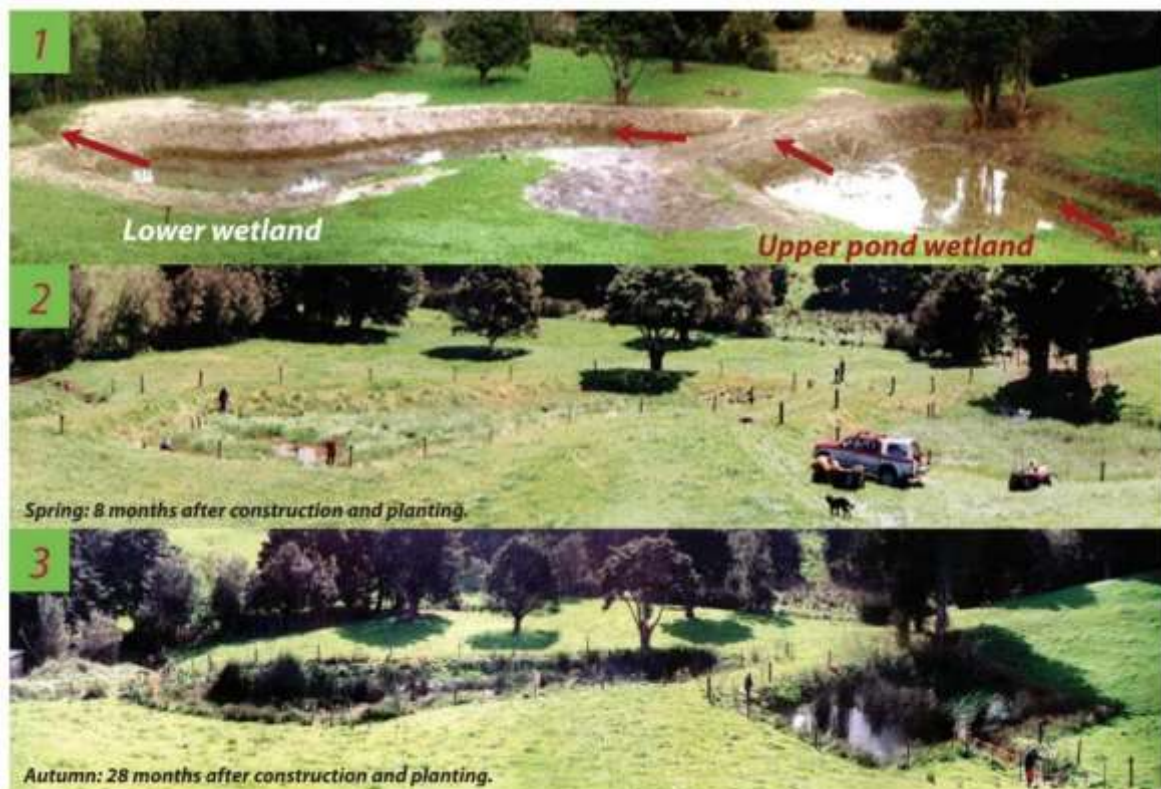
Figure 22 A 900 m² interception wetland with a coarse sediment trap at the top end (right) draining 5.65 ha (revised) (Tanner et al. 2010; 2011)

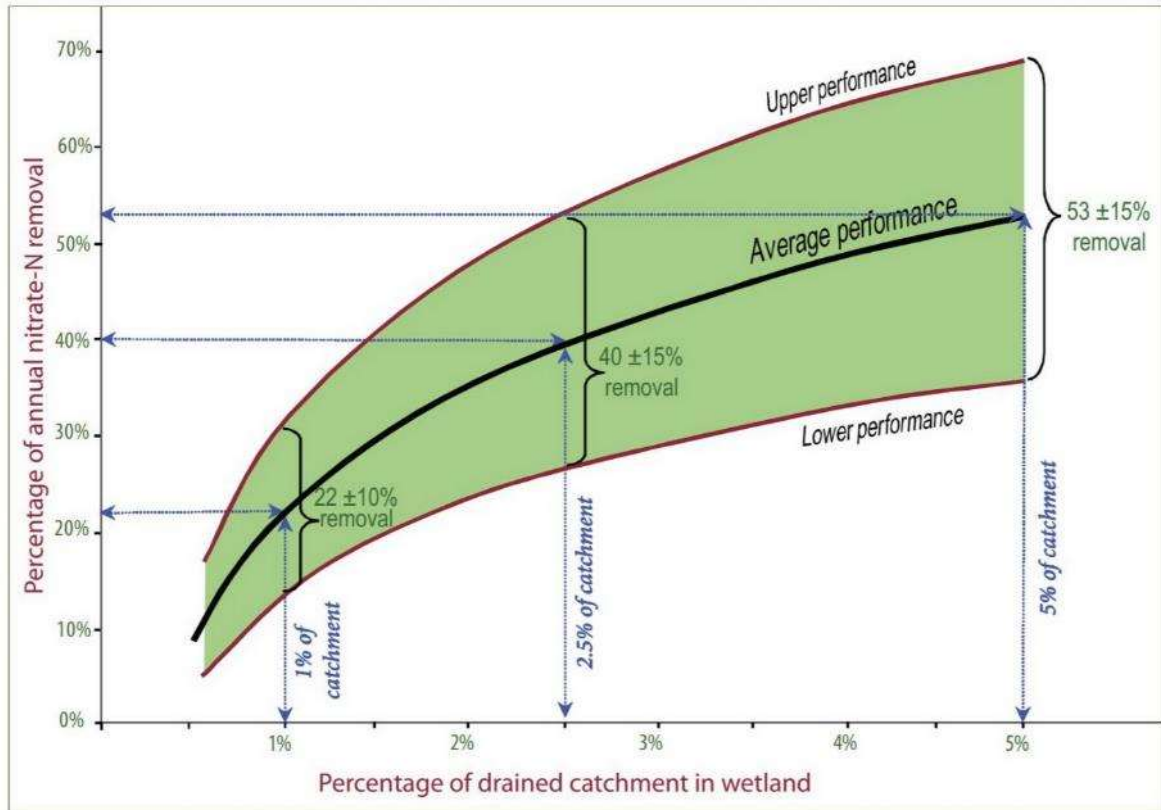
Figure 23 Constructed wetland size and performance (Tanner et al. 2010)

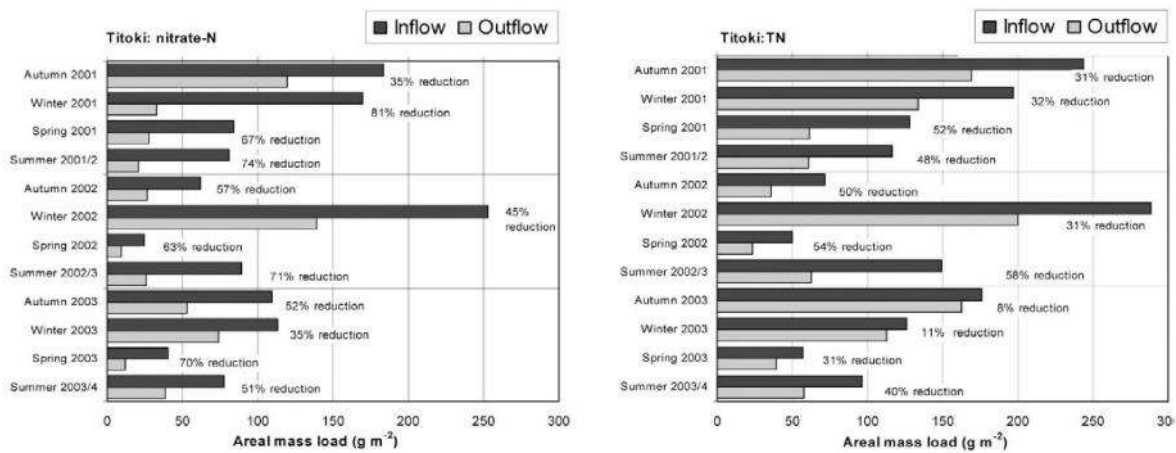
Figure 24 Titoki wetland performance (Tanner & Sukias 2011)

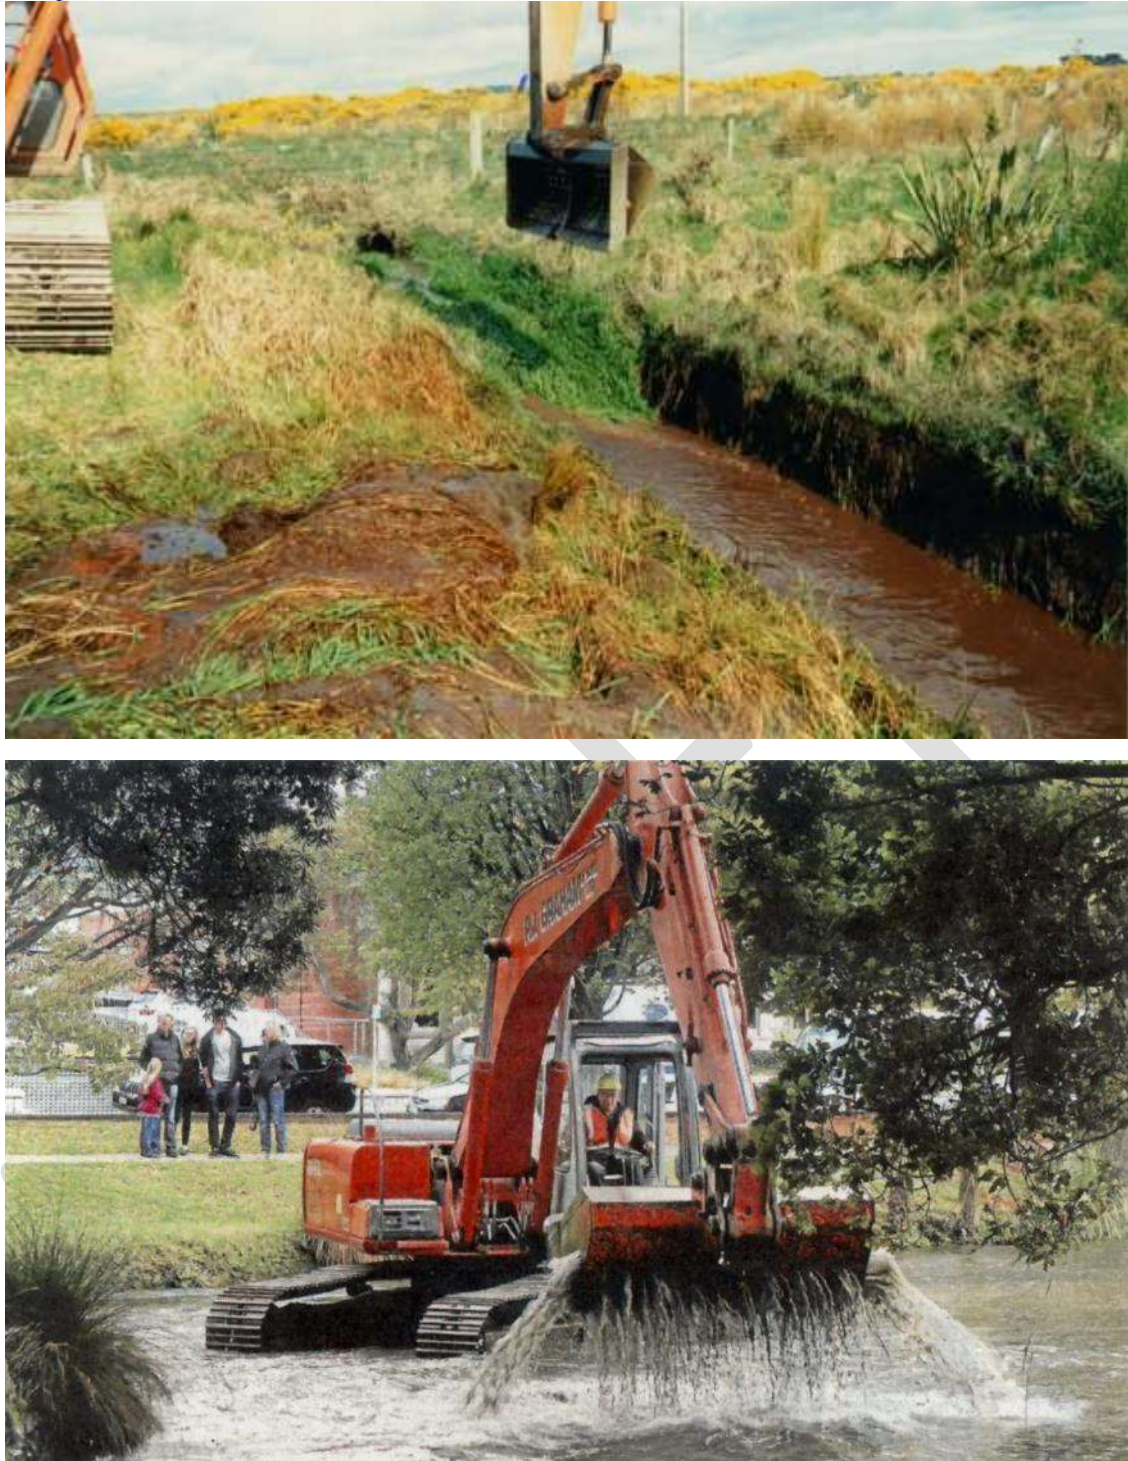
Figure 25 Hydraulic excavators are commonly used to remove sediment (and weeds) from the bank (Duck Creek) and inchannel (Avon River - Sunday Star Times 04 May 2014)

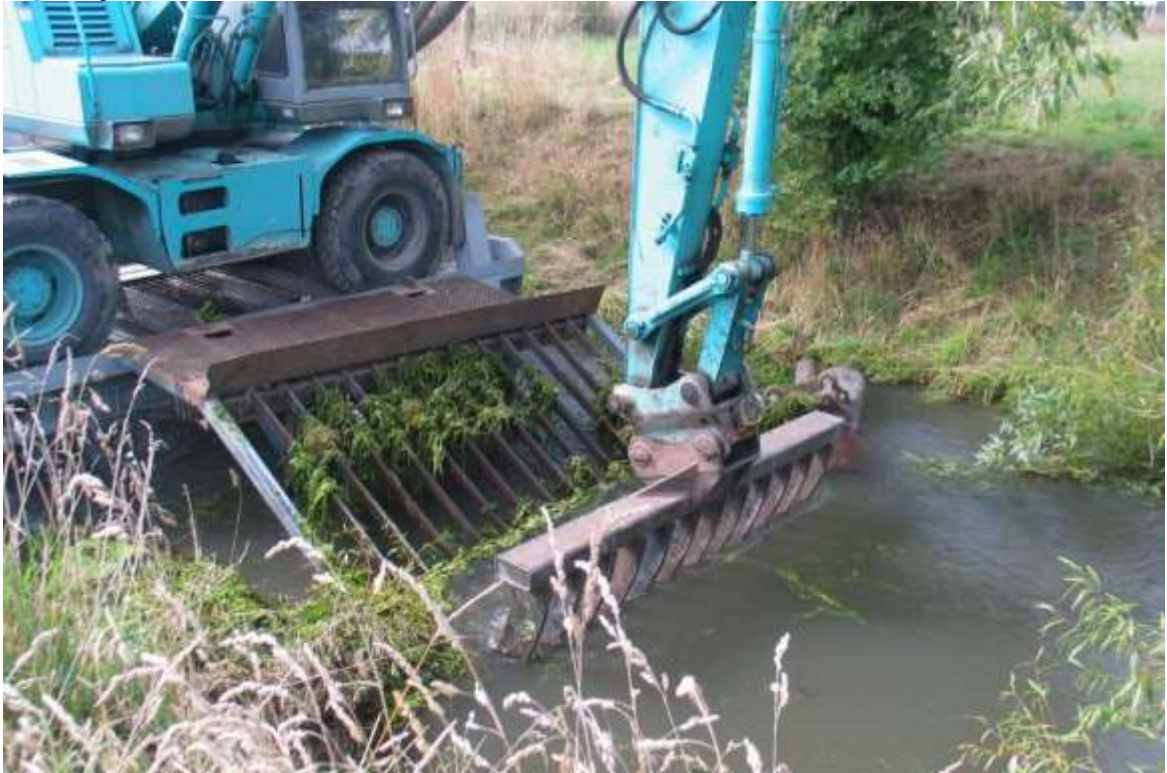
Figure 26 Rake bucket used in the Waimakariri District for aquatic weed removal
