Scoping strategy for the Three Brooks and channel enhancements in the middle Cam River and Tuahiwi Drain

Prepared for Waimakariri District Council
Prepared by Dr Henry R Hudson
Environmental Management Associates
Nelson
(+64) 027 284 4239

*Report 17-04
April 2017*

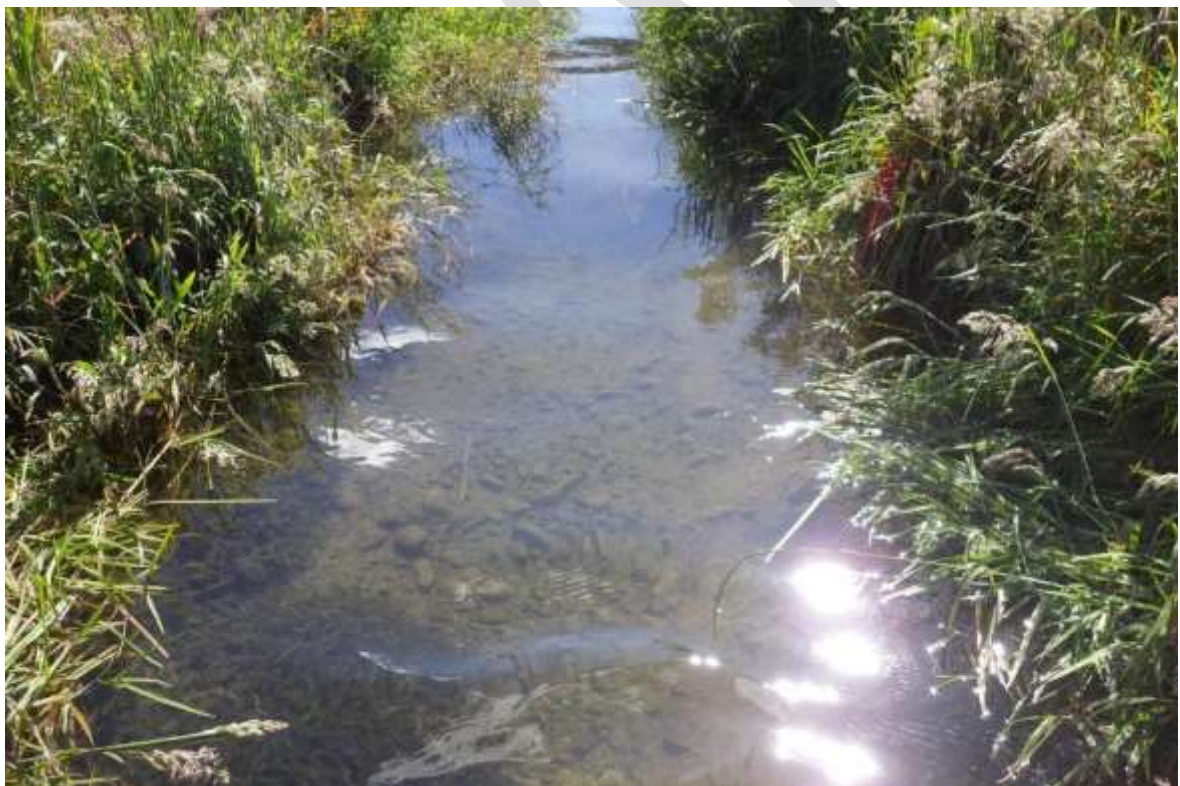
Figure 27 Exposed gravel with marginal fine sediment deposits in the bed raking reach Middle Brook

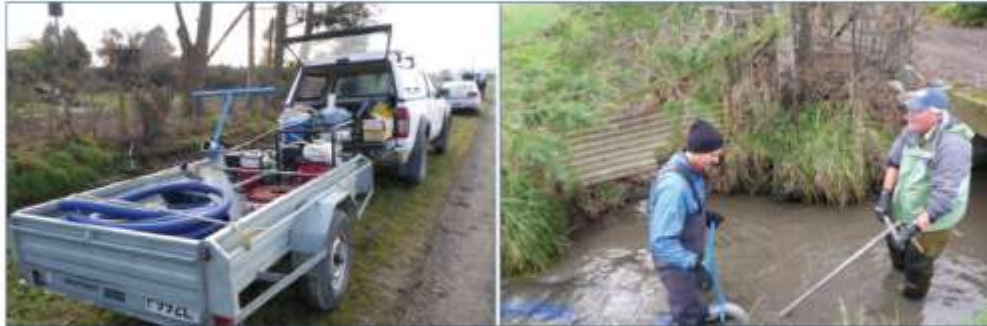
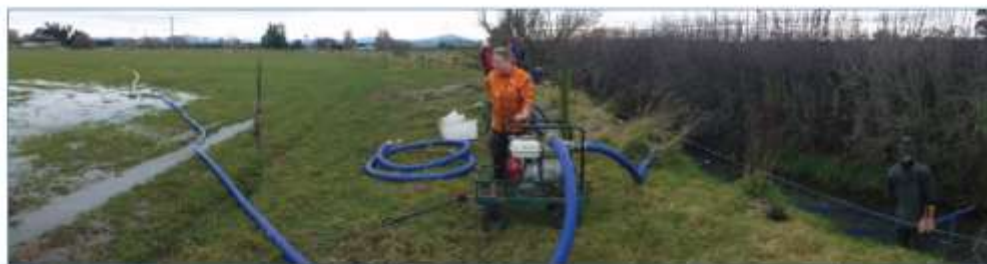
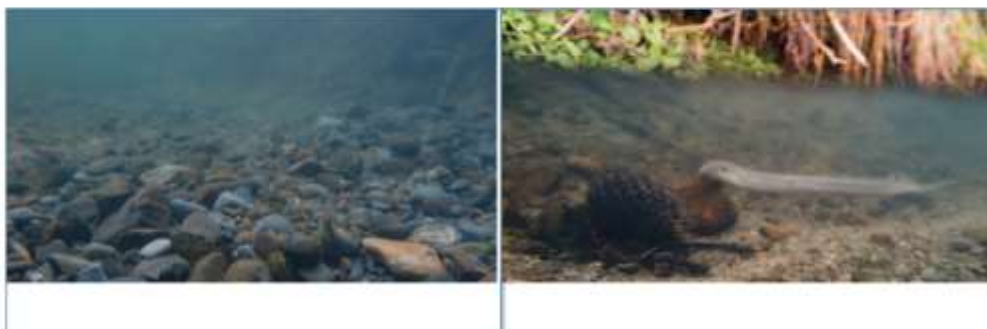
A Sand Wand™ (Streamside Environmental) was used to remove sediment from two sediment traps and three 10m reaches of a small waterway (approx. 2.5m wide).

Sand wandling resulted in a reduction of fine sediment cover from approximately 40% cover to 10-20% cover. The sand wand was effective at removing loose sediment from depositional habitats (e.g., a pool or sediment trap) but doesn't work well in shallow water (<20 cm deep). The wand is labour intensive and the removed sediment needs to be deposited elsewhere.

Sediment removed from the waterway using the sand wand was dispersed on an adjacent paddock.

Waterway bed substrate revealed and a lamprey that came to check out potential new habitat after sand wand was used.

Figure 28 Sand wand trials Middle Brook (Harding et al. poster 2 undated)

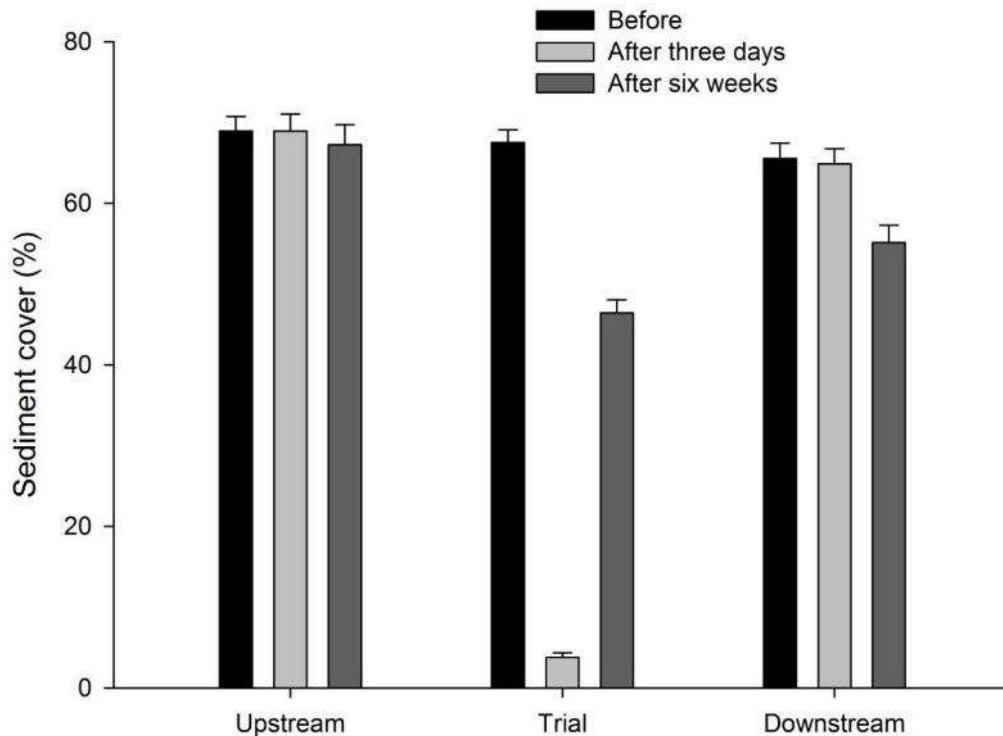
Mean (\pm 1SE) sediment cover within, upstream and downstream of the trial reach. Sediment cover was estimated using a stream bed viewer, $n = 80$. Differences ($p < 0.05$) between groups and occasions were derived from a two way ANOVA on ranked values

The initial removal of fine sediment, at least on the surface of the stream bed, was very successful with a significant removal of fine sediment. However, over time fine sediment has returned and deposited on the bed, almost reaching pre-trial levels of cover. The source of new sediment to the treatment reach may be deeper deposits within the reach itself or upstream reaches. The latter source appears more likely, particularly given the unusually high flows in the stream between sampling periods. However, despite the migration of fine sediment into the trial reach, sediment cover remained at a lower level than prior to the trial.

Figure 29 Sand wand trials Otukaikina Creek (Gray et al. 2013)

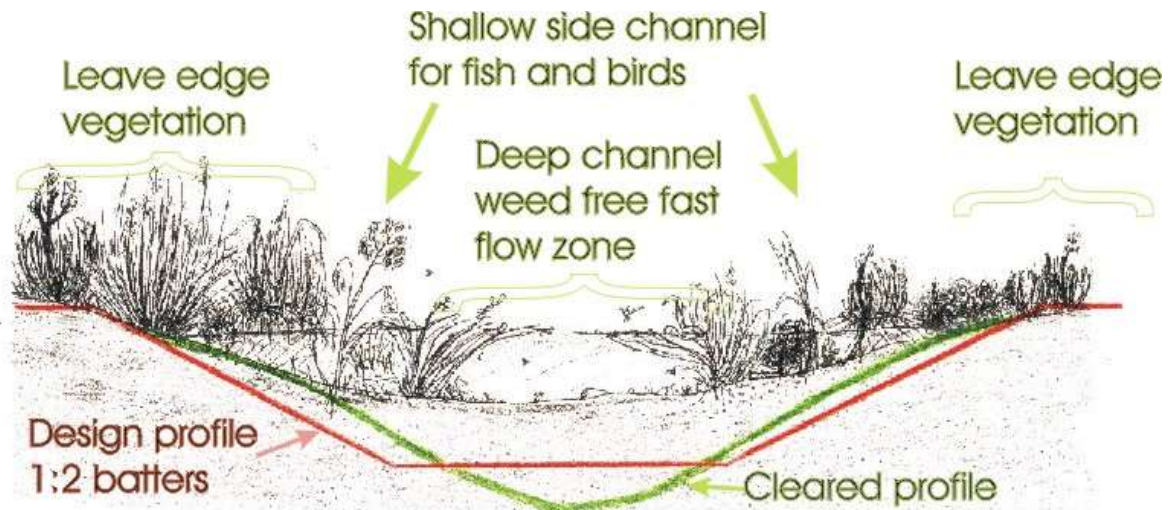
Figure 30 Partial drain clearing, leaving shallow vegetated margins, to concentrate flow to maintain a weed and sediment free narrower channel (Hewson & Hudson 2000)

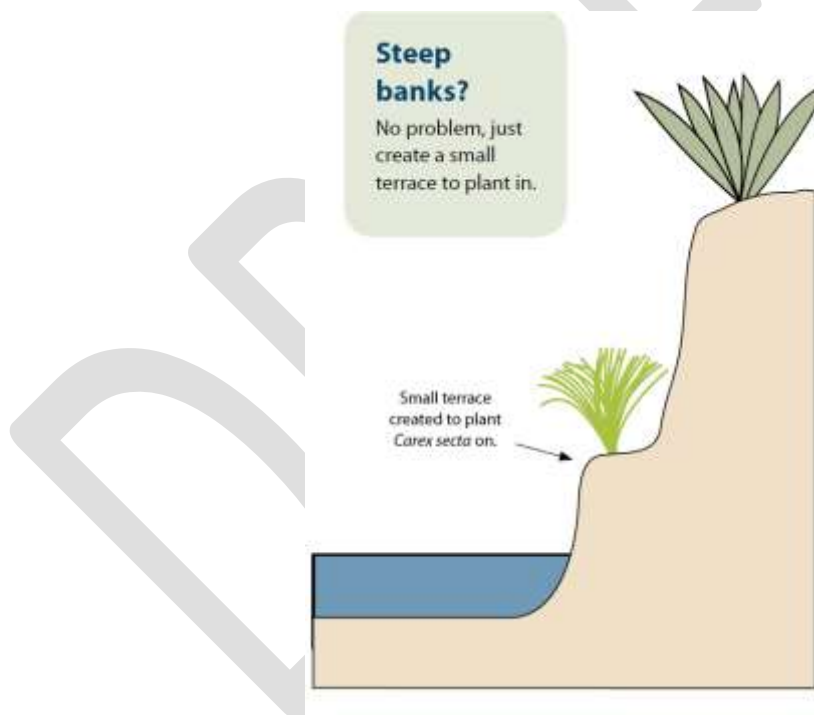
Figure 31 Benching steep banks to provide a planting platform (Environment Canterbury Living Streams Handbook Part 3: Planting and maintenance)

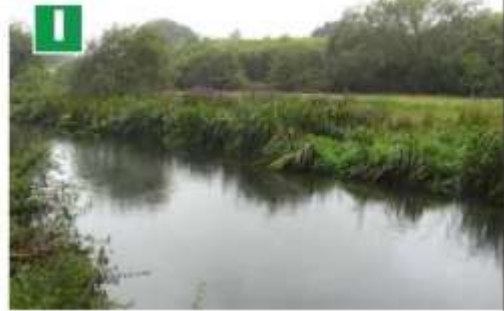
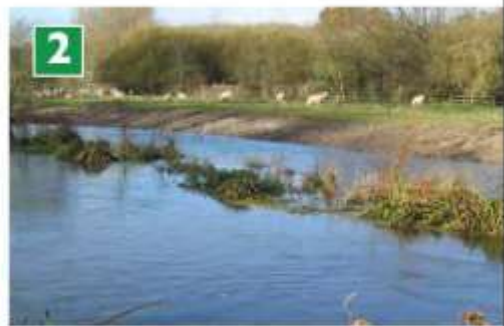
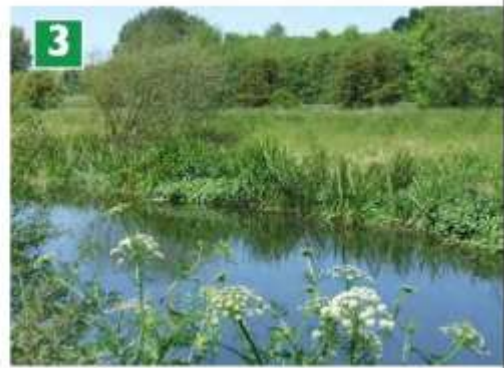
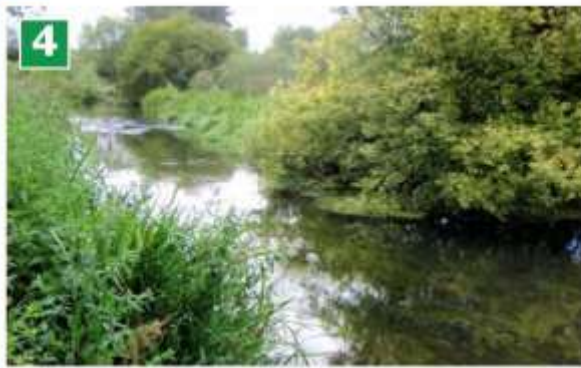
The upstream end of the new bank takes the brunt of flow and may need to be protected from erosion. In the STREAM project, the bank sliding was therefore done immediately downstream of an overhanging willow tree **4**. A flow deflector can be installed as an alternative.

Figure 32 Bank sliding (Advice note River Restoration)

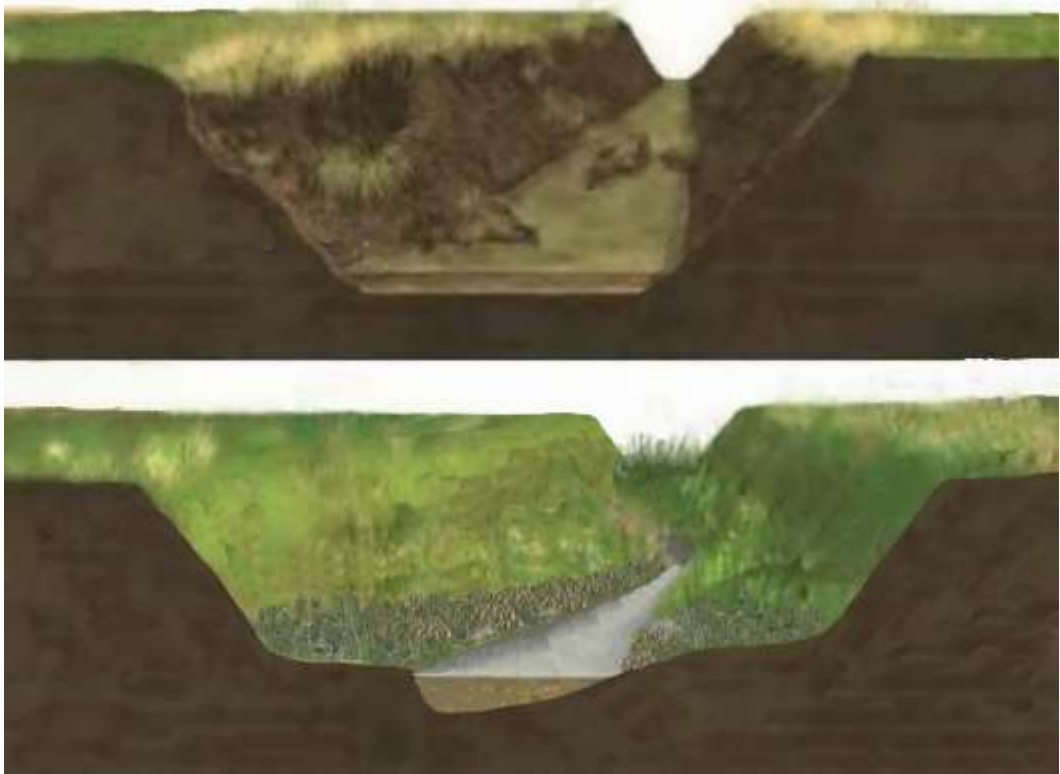
Figure 33 Two stage channel design providing a narrow low flow channel and periodically inundated vegetated high flow channel

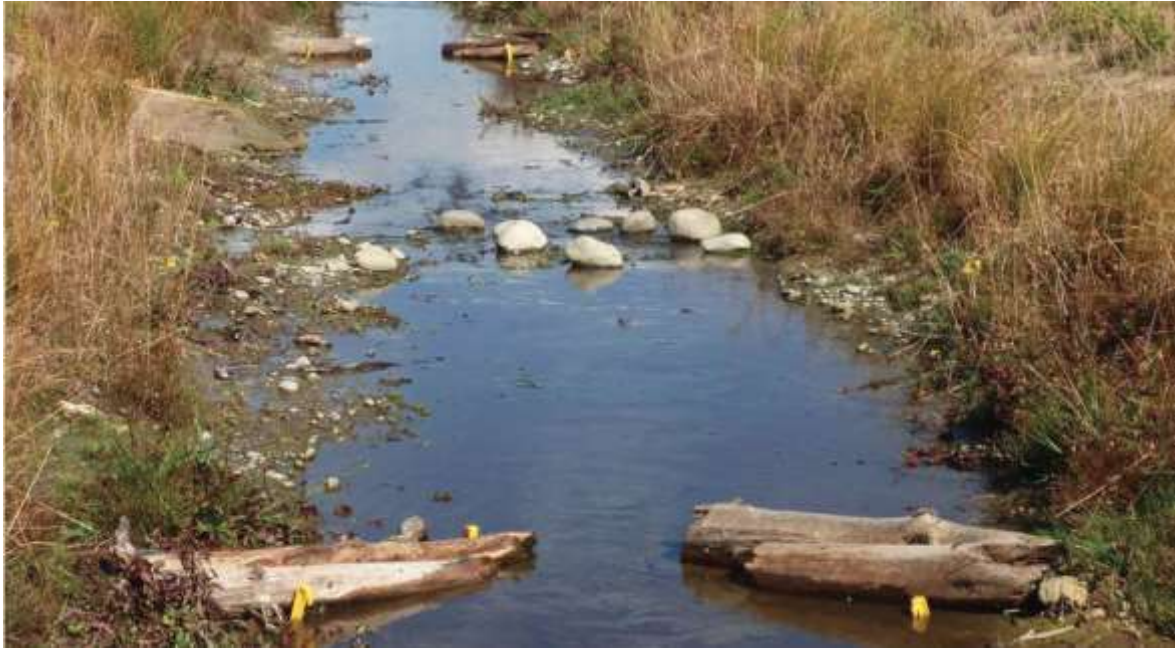
Figure 34 Addition of boulder clusters and logs for habitat diversity (CAREX Newsletter May 2015)

Natural boulders and wood logs have been added to one of our waterways to demonstrate the value of habitat for freshwater insects and fish. Many agricultural waterways lack important habitat for freshwater animals. Monitoring has shown this habitat is being used by insects to lay their eggs and fish are using them for cover. Our plan is to trial a larger-scale demonstration later this year.

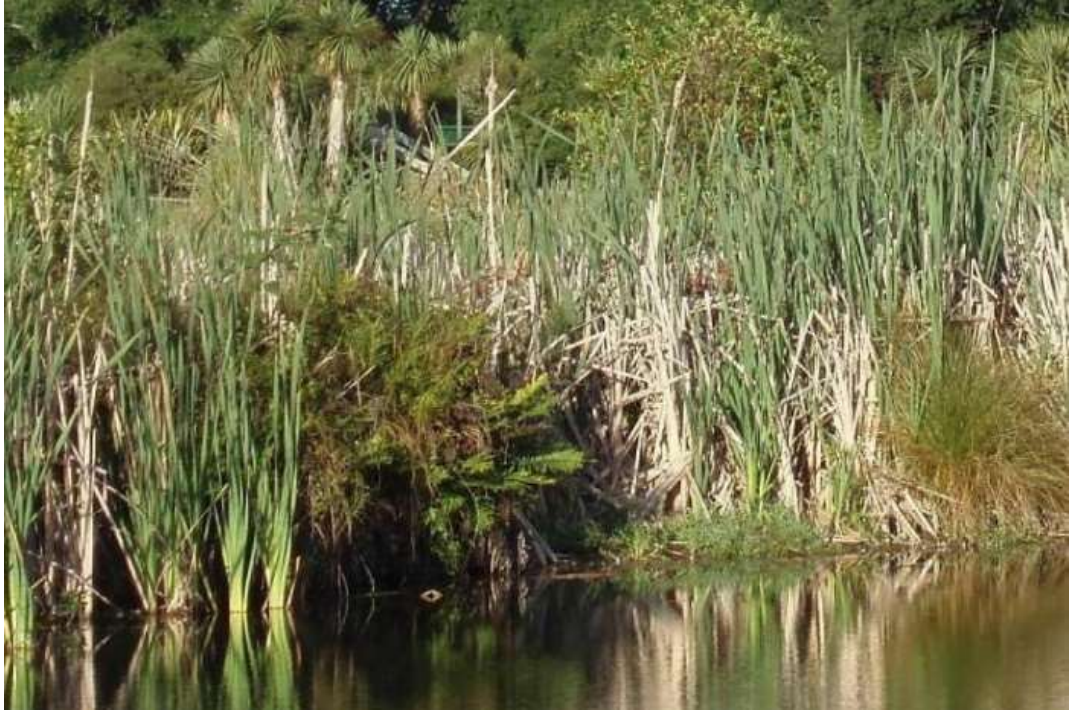
Figure 35 Edge planting of raupō , carex secta (pukio/flax) and kiokio fern (*Blechnum novaezelandiae*) with cabbage tree (*Cordyline australis*) in the background

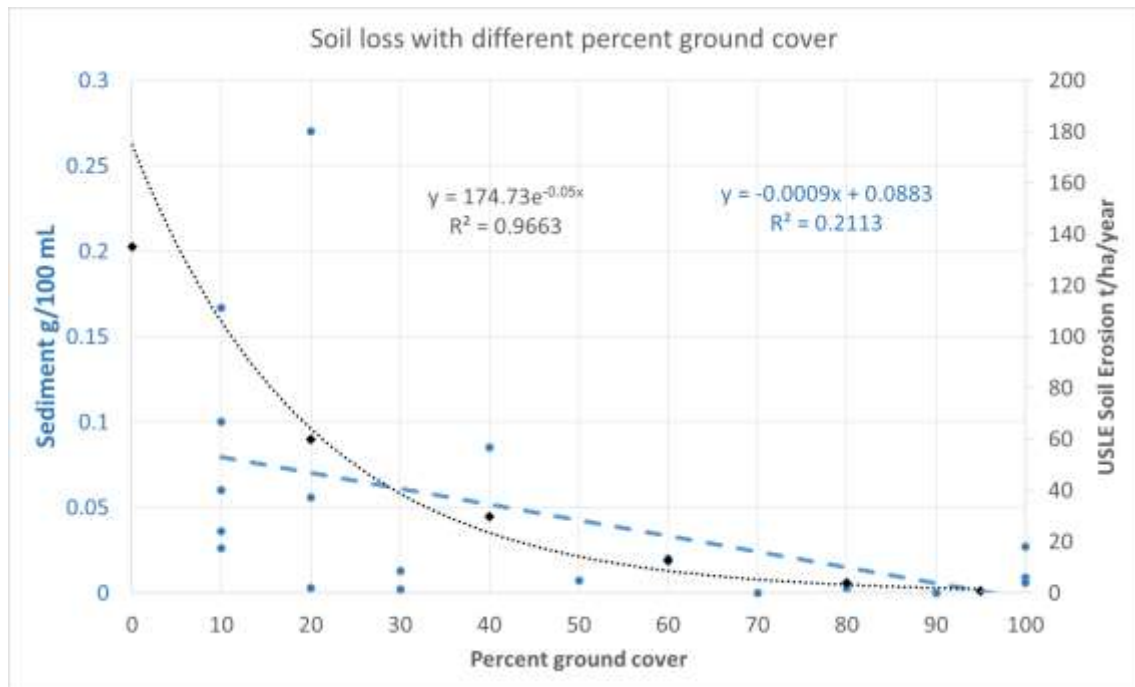
Figure 36 Graph of sediment loss with percent ground cover (CAREX poster 2) superimposed with predicted soil loss for a hypothetical drain bank

Comment: CAREX poster 2 (Harding et al. undated), showing a graph from Porter (2014), under the title “How can we reduce reducing fine sediment in waterways, states “maximising riparian vegetation cover e.g. >50% grass cover.”

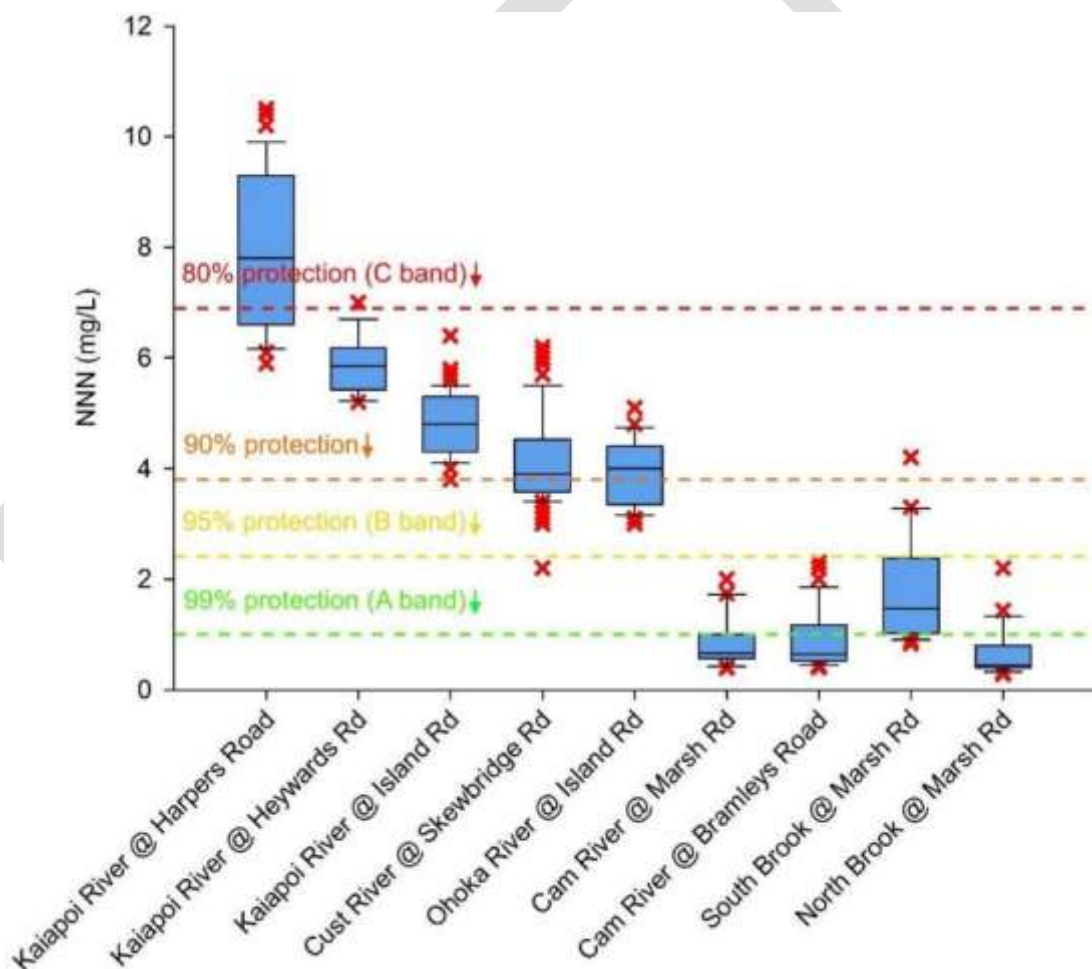
Figure A2: 1 Distribution of NNN concentrations, with thresholds for the protection of biodiversity from nitrate toxicity (Hickey 2013) and NPS (2014) bands.

NNN concentrations are stable or downward trending at the study sites. Under the NPS for freshwater management (MFE 2014) national bottom lines for nitrate toxicity are not being met in the upper Kaiapoi River which requires better management of nutrient inputs to meet the C band requirement at Harpers Road. Median values for Cam system sites are below the A band; with a high degree of protection of biodiversity (99%), the exception being South Brook at Marsh Road with is generally between the A and B bands (Figure A2: 1). The 95th percentile values (1.87 mg/L, 2.22 mg/L, 1.78 mg/L and 3.5 mg/L for the Cam at Marsh Road, Cam at Bramleys Road, North Brook at Marsh Road and South Brook at Marsh Road, respectively, exceed the threshold for 99% protection of biodiversity, but not the 95% protection level.
